SUBJECT: Design Memorandum on Pier Repair Project at
Olcott Harbor, New York

DESIGN MEMORANDUM

PIER REPAIR PROJECT

OLCOTT HARBOR, NEW YORK

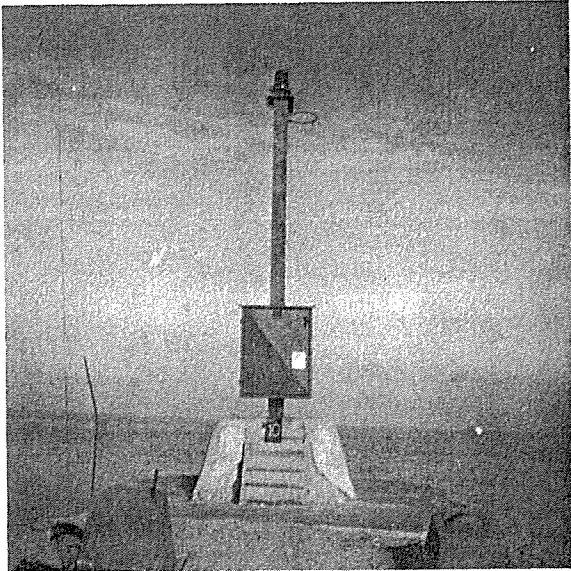
Photo No. 1 - View of light at outer end of pier.

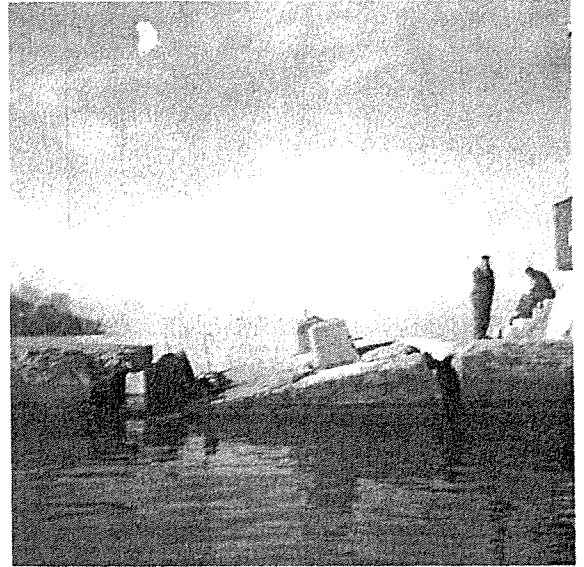
Photo No. 2 - View from channel of section of pier from sta. 2+35 to 3+15.

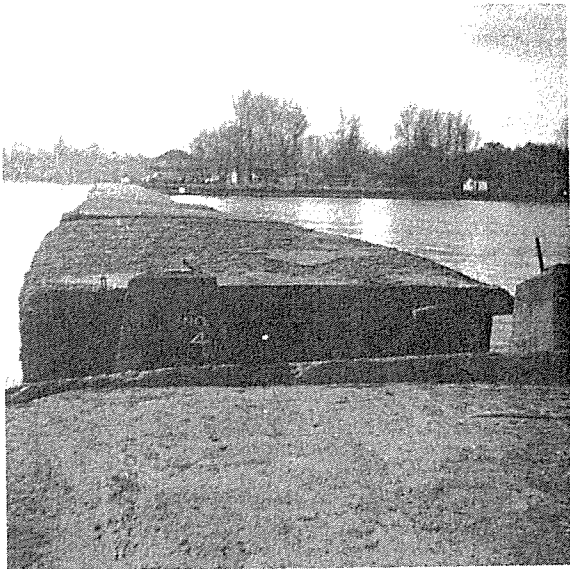
Photo No. 3 - View along pier crest toward shore from steps shown in Photo No. 1. Shoreward sections of crest show evidence of differential tilting of timber crib substructure.

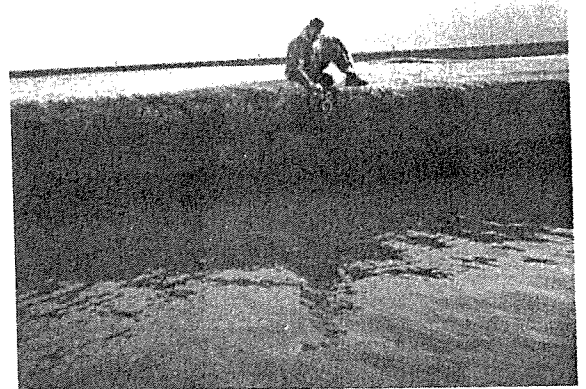
Photo No. 4 - View from lake side of section of pier from sta. 4+00 to 4+30.

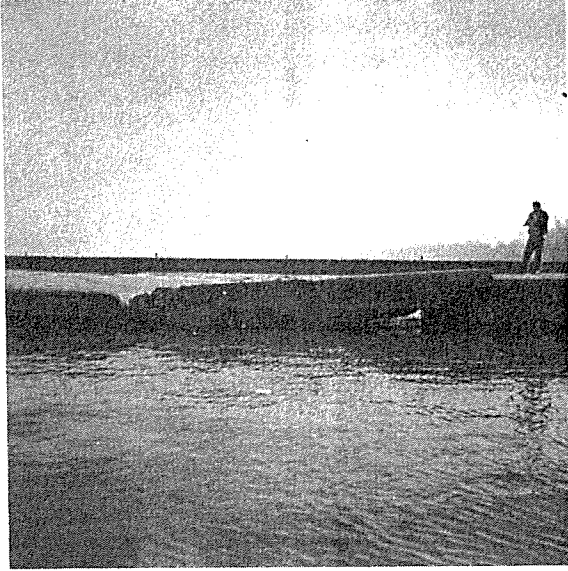
Photo No. 5 - View from lake side of section of pier from Sta. 4+50 to 4+90. Note east pier, repaired in 1949, in background of this and Photo No. 4.

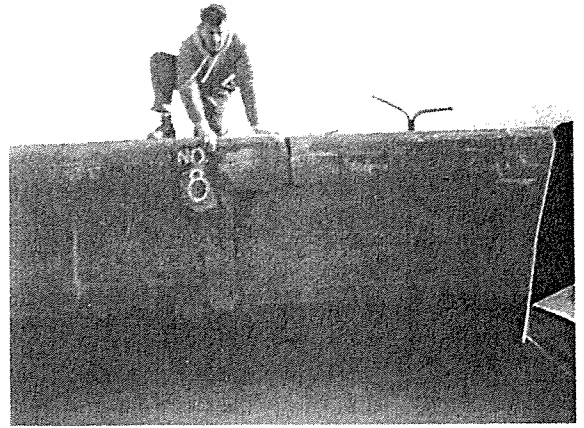
Photo No. 6 - View from lake side of section of pier from Sta. 5+00 to 5+20. Here, only superficial signs of deterioration are evident.

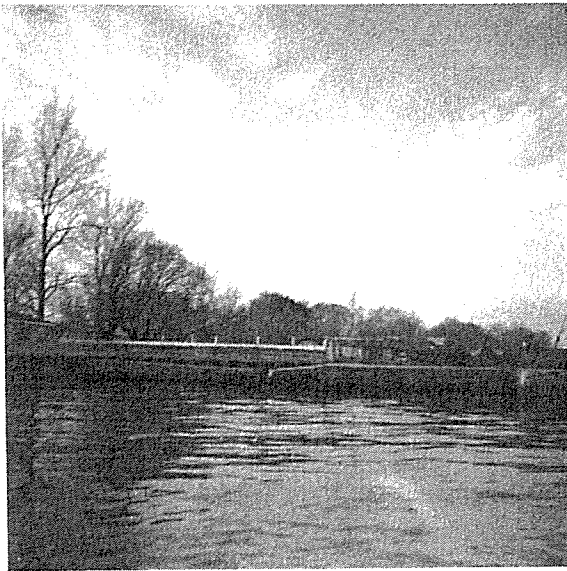
Photo No. 7 - View from channel of section of pier from Sta. 7+90 to 8+90, showing the inner end of the 20-foot wide portion, the 9-foot wide portion, and the 5-foot wide portion.

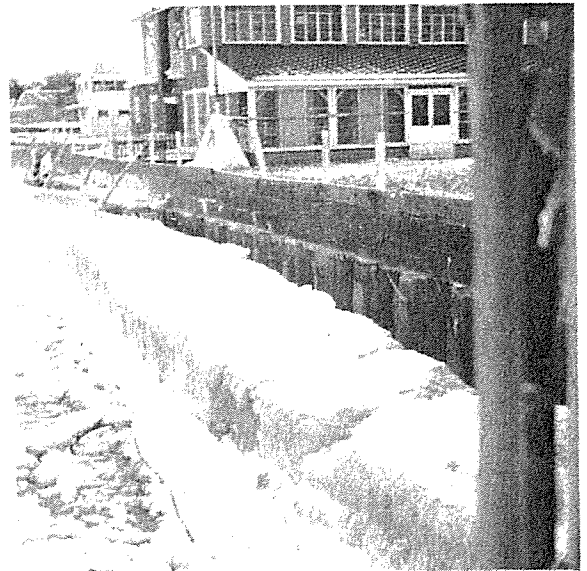
Photo No. 8 - View of the 5-foot wide portion of the structure, showing piling driven in 1914 in left background. Note line of piling driven by Yacht Club behind pier and old piling. (Structure in right foreground in part of core drill rig).

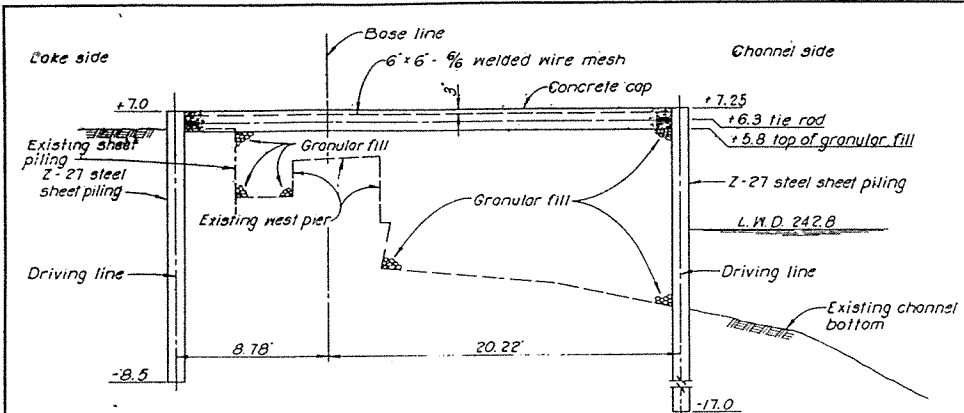
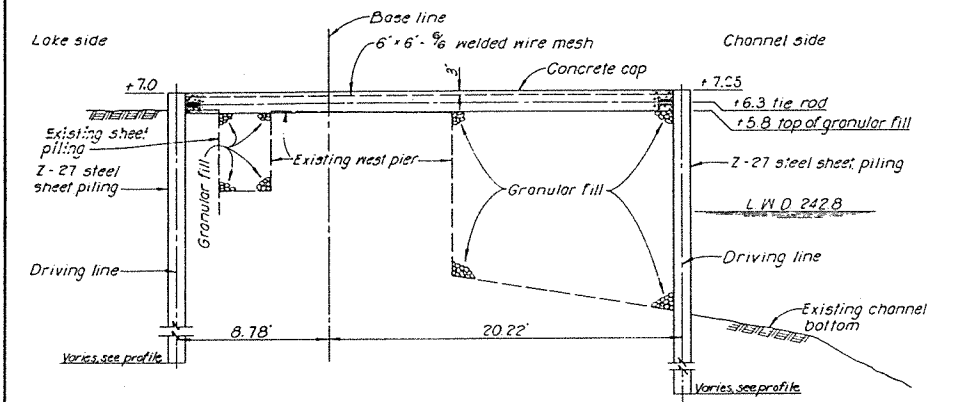
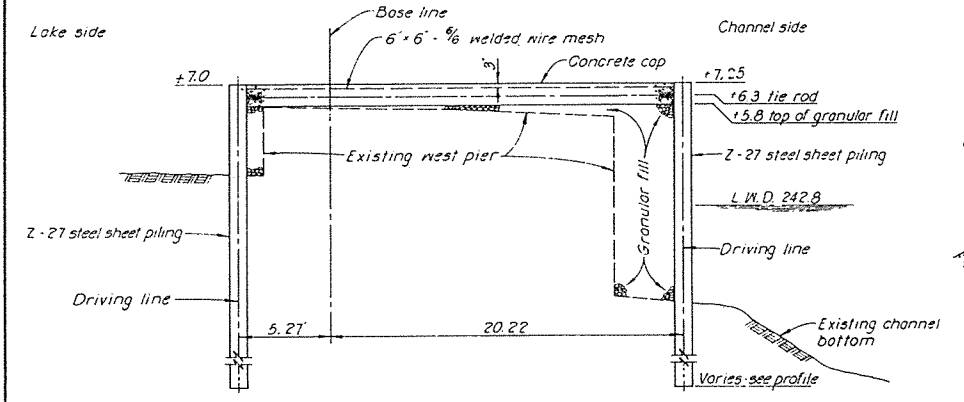
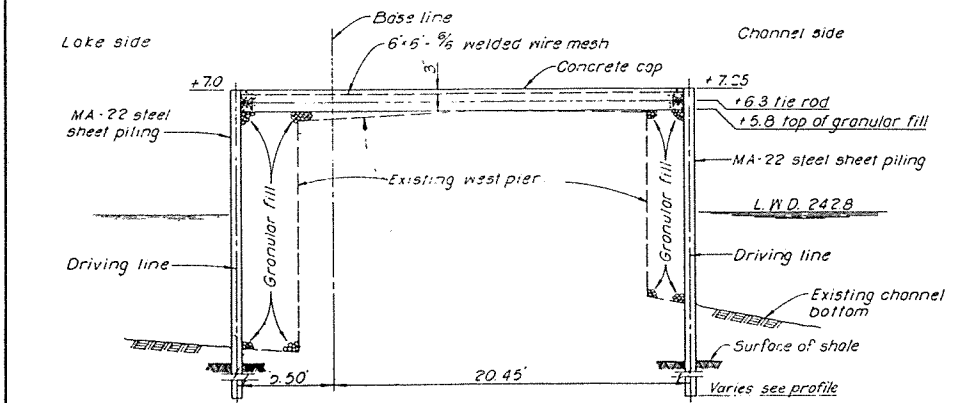
TYPICAL CROSS SECTIONS OF REPAIR TO WEST PIER
SCALE: 1" = 4'

c. Consideration should be given to locating the wales on the outside surface of the piles rather than on the inside as shown on the Plate 1 cross-sections.

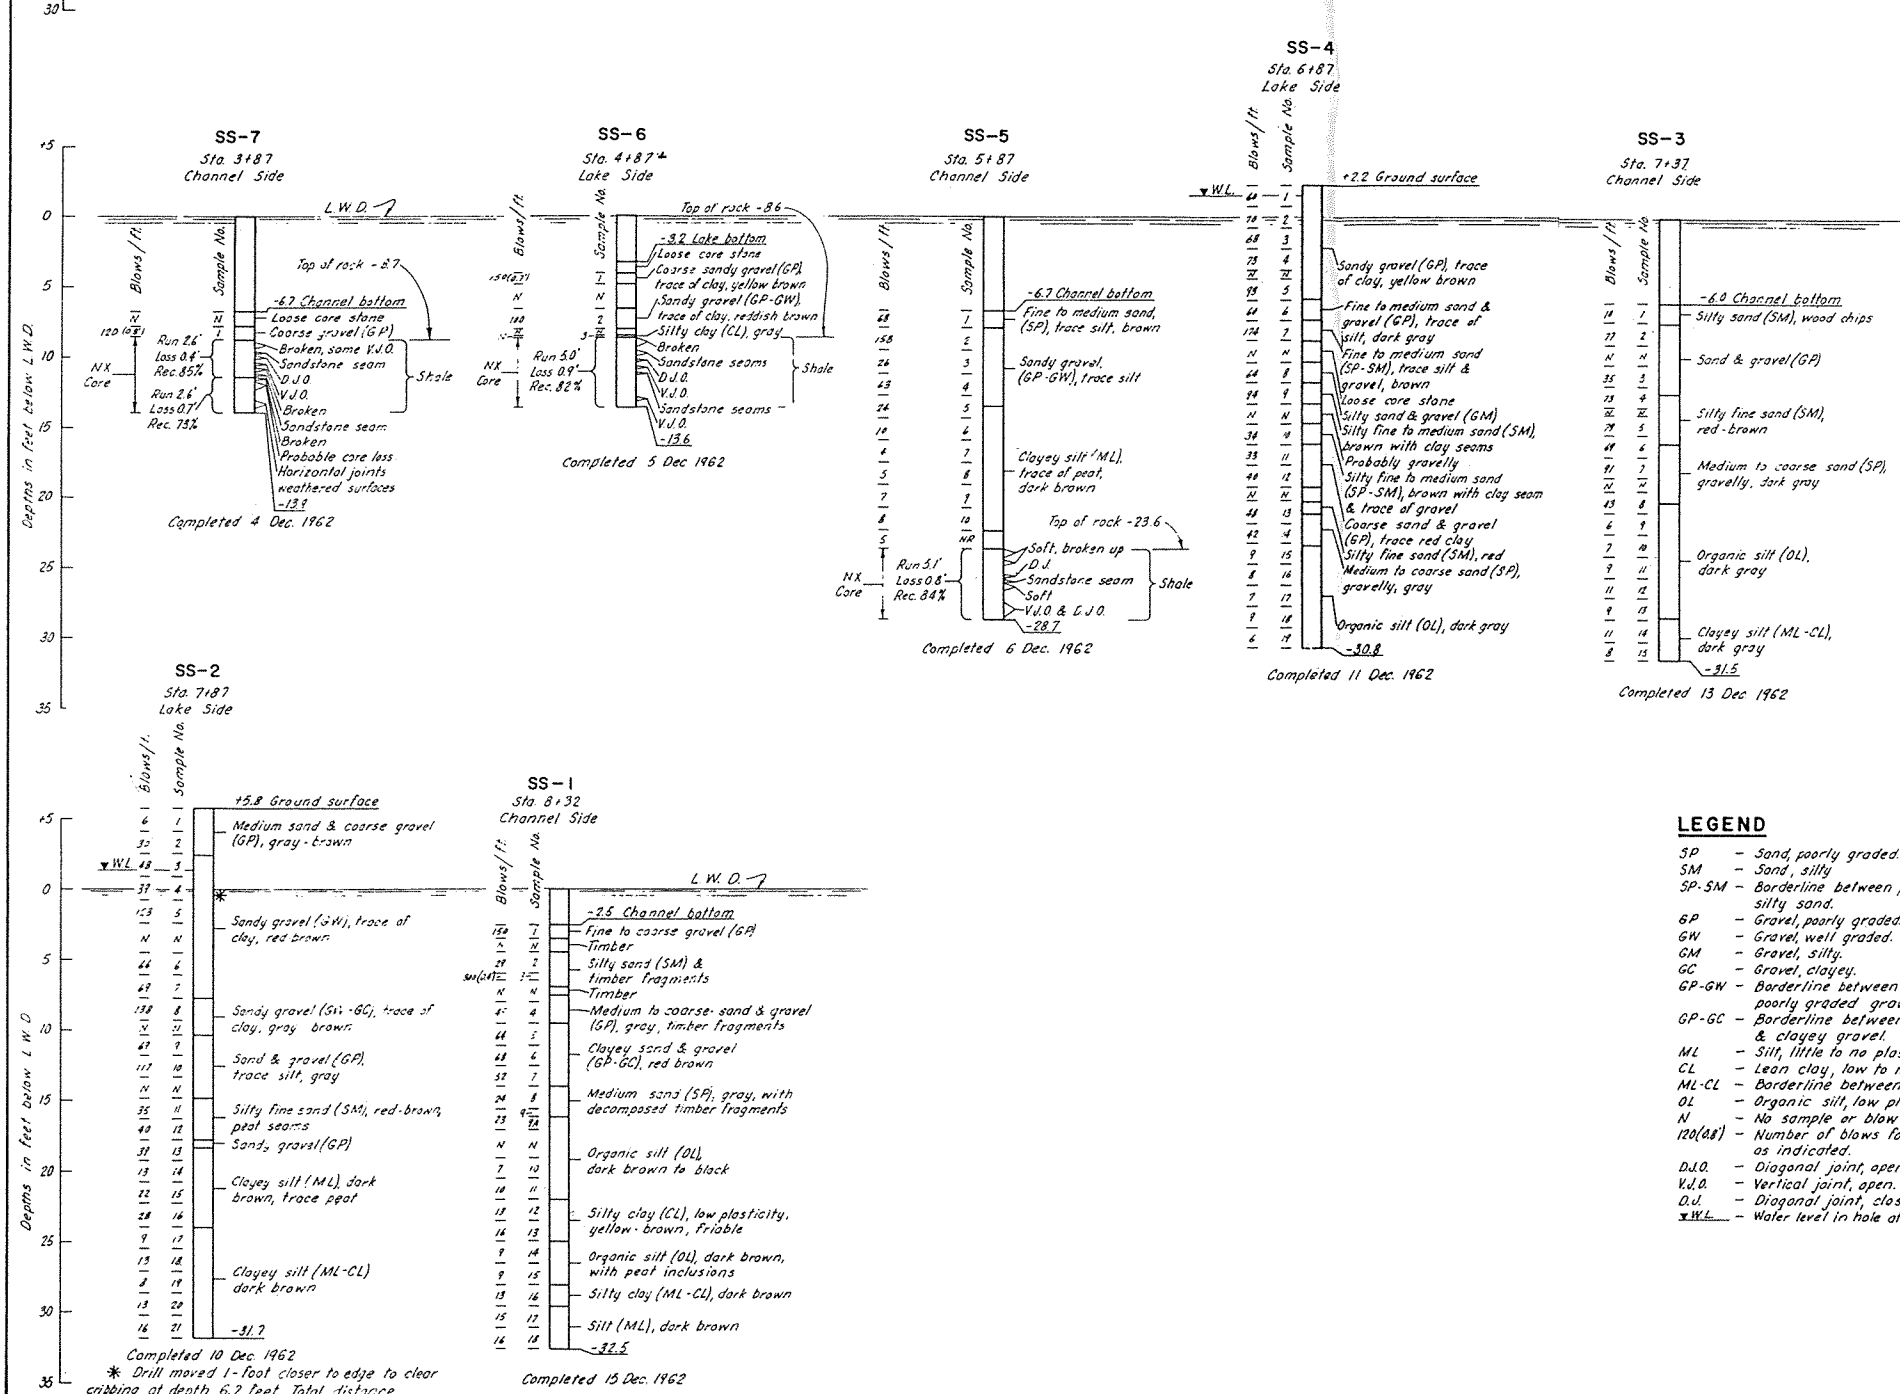
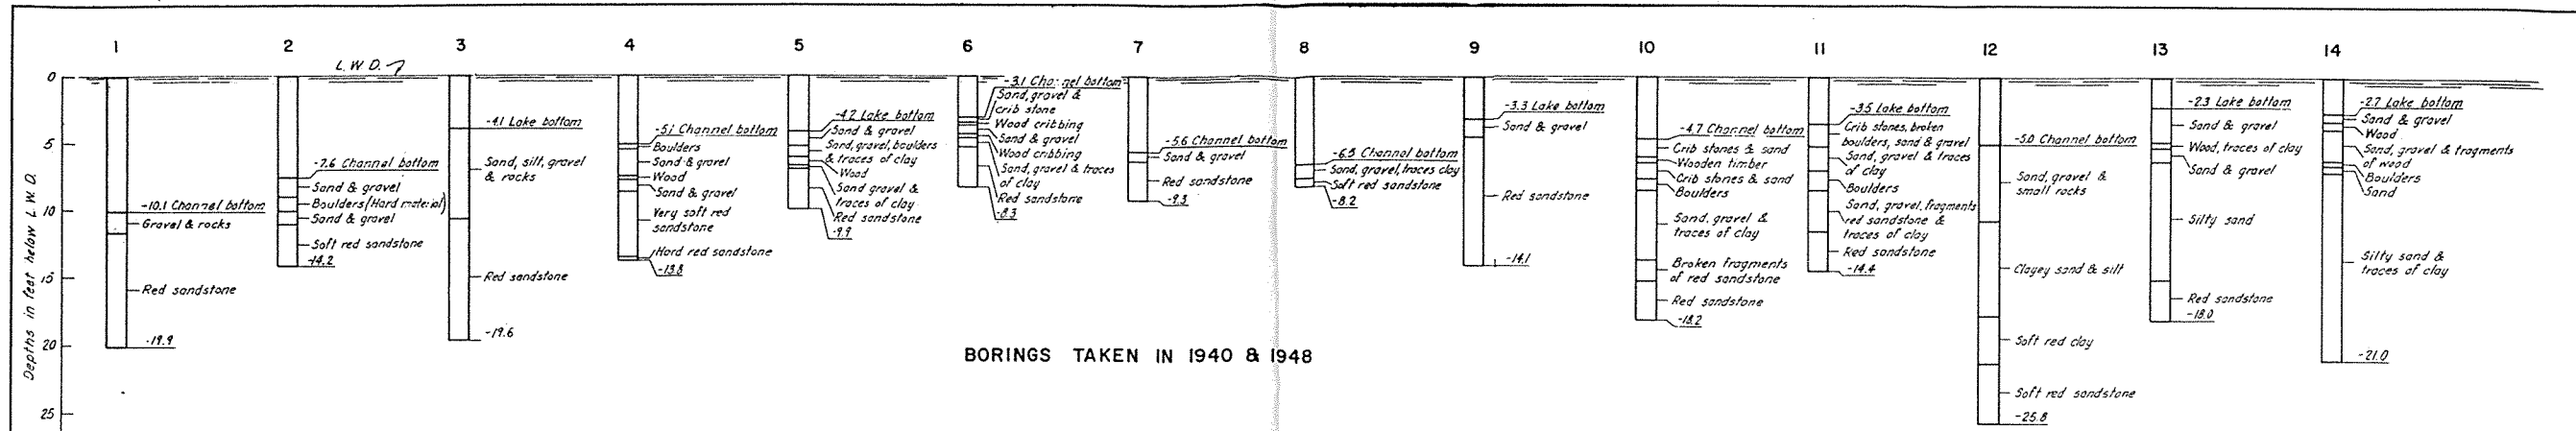
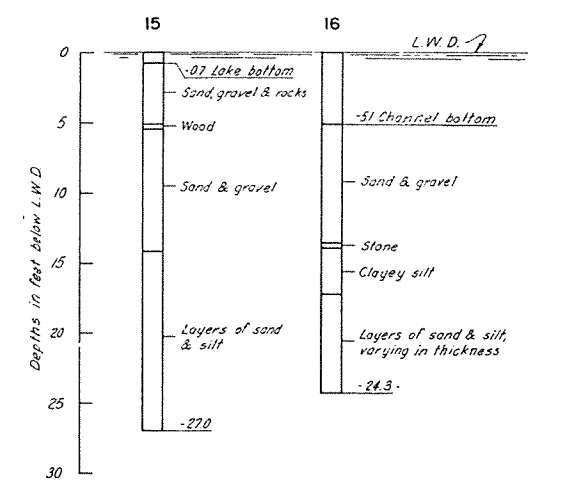
BORINGS TAKEN IN 1940 & 1948

(1) Inasmuch as the descriptions, especially those for the rock, on the logs for borings made in 1940 and in 1948 do not agree with those shown on the logs for the more recent borings, some indication of the reliability of the descriptions or an explanation for the disagreement should be given if this drawing is to be included in the contract drawings.

(2) Also, it is the understanding of persons in this office that cores and samples from the 1940 and the 1948 explorations are not now available for inspection. If this is true and if the drawing is to be one of the contract drawings, the lack of availability of these cores and samples should be indicated.

(3) In note 4, this office questions the description of the shale as "hard" inasmuch as a hard rock is one that cannot be scratched with one's fingernail (Plate 2, EM 1110-1-1806). Maybe definitions of hardness terms should be included in the drawing.
