BURT DAM

NIAGARA COUNTY, NEW YORK

INVENTORY No. N.Y. 745

PHASE I INSPECTION REPORT
NATIONAL DAM SAFETY PROGRAM

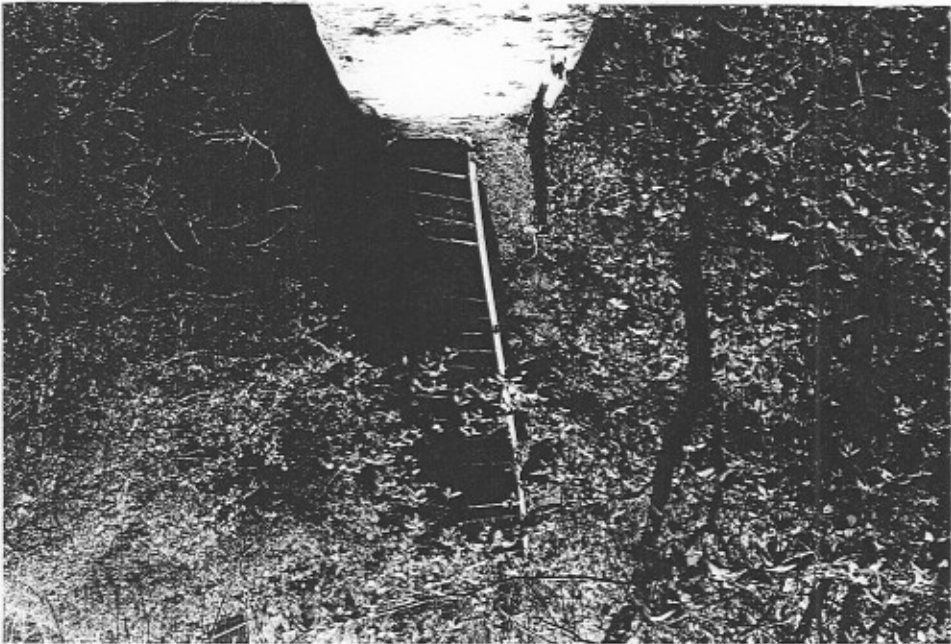
3. Stairs at east abutment

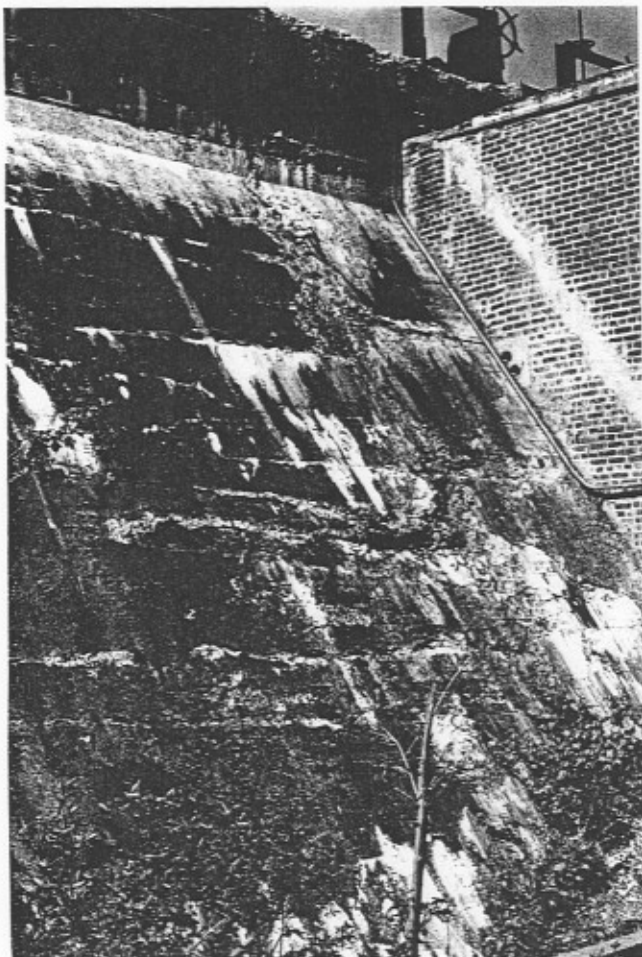
7. Downstream face of dam near east abutment.
Note spalled concrete.

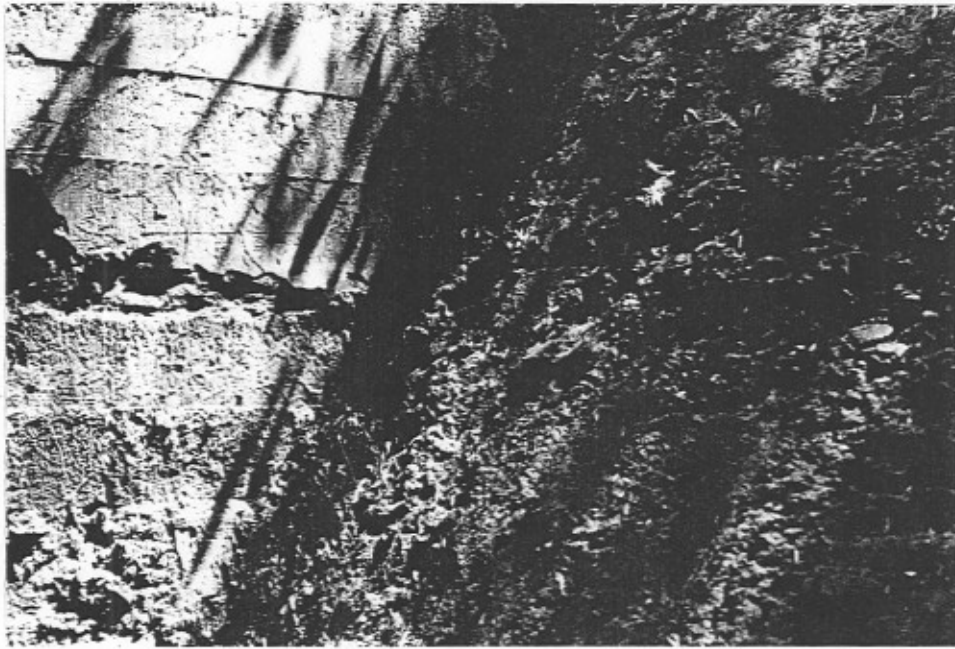
11. West face of west spillway wall. Note water trickling down face of dam.
