**Eighteenmile Creek Restoration Project
Town of Newfane
Niagara County, New York**

**DRAFT
Restoration Monitoring Plan for the
Eighteenmile Creek Habitat Restoration
Project**

February 9, 2005

Prepared By:
Ecology & Environment, Inc.

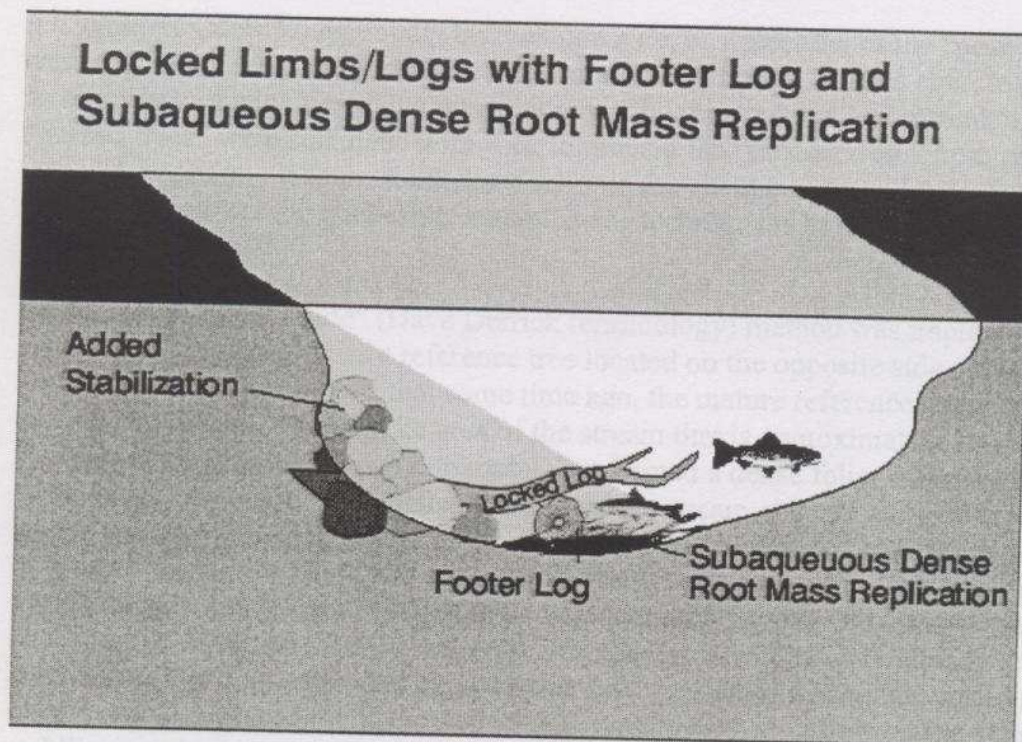
Inspection and Performance

May 10, 2004

All locked logs were intact and functioning as constructed. The subsurface bank with stone stabilization was in the constructed position. The stabilized locked log had collected some submerged plant and small woody debris, but appeared to be functioning properly. There was no obvious alteration of flow beyond a slight reduction of velocity with a calm water zone near the base of the locked log. Small fish were observed in this area.

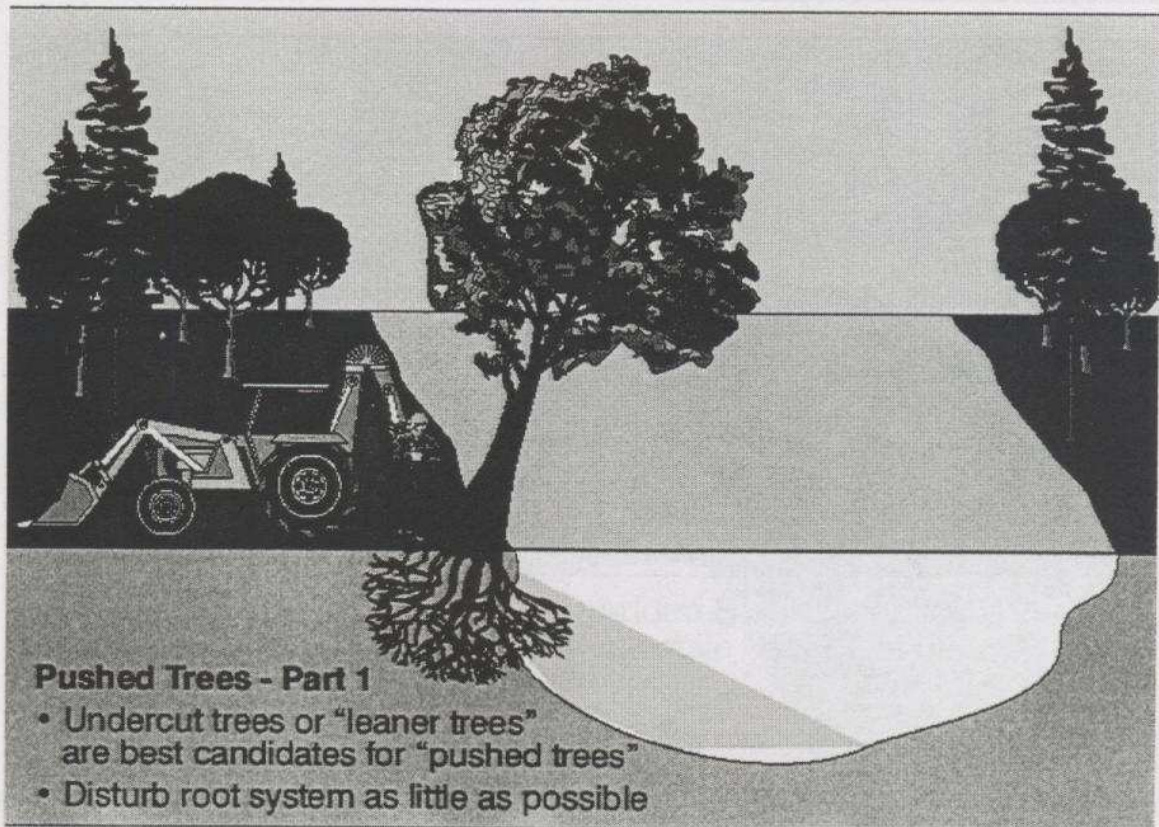
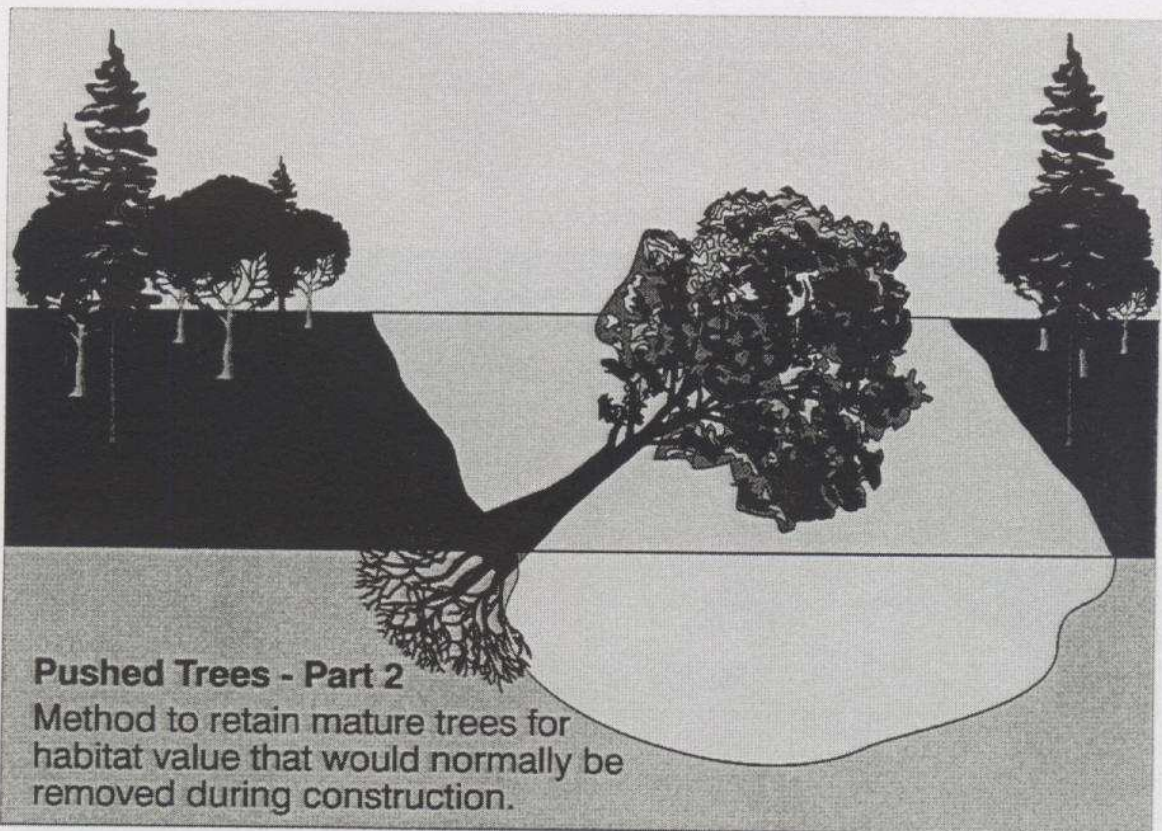
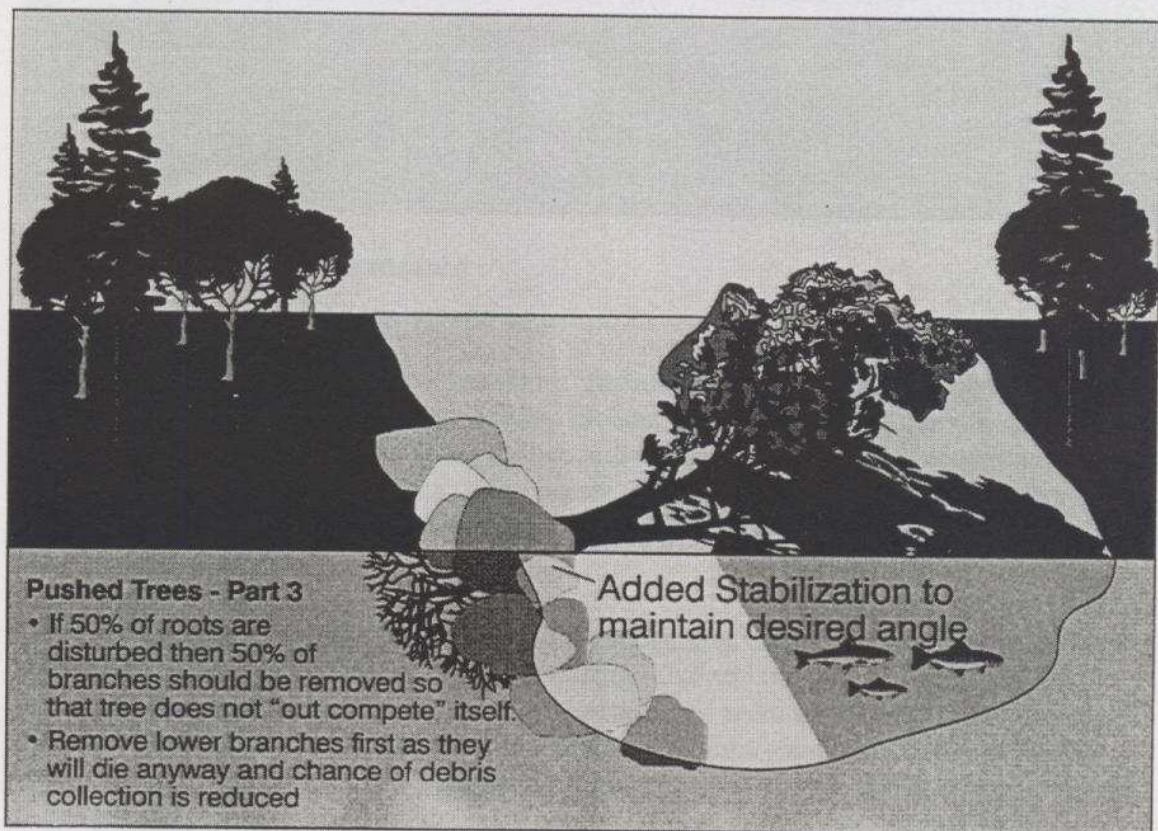
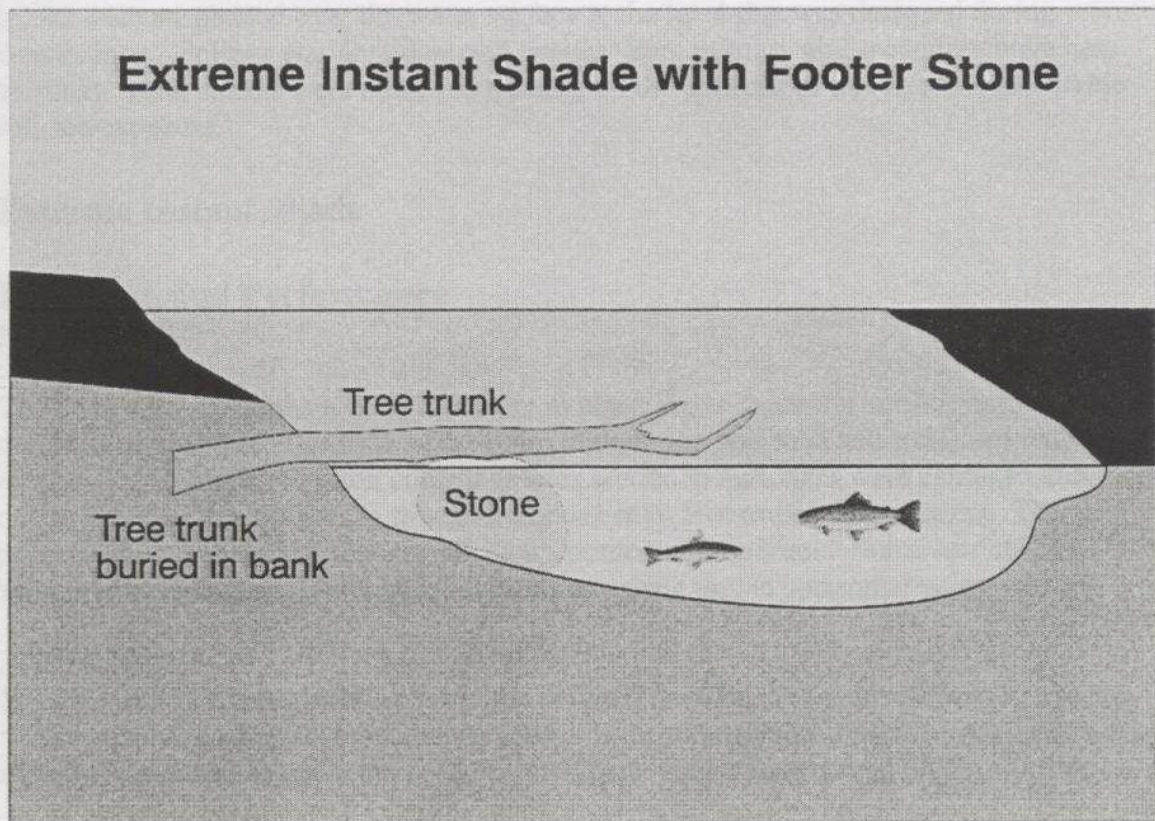
Inspection and Performance

May 12, 2004

The leaner trees (*Acer negundo* – box elder) Instant Shade features were observed to be in place as positioned during construction. Bolster stones to support trees in an upright angle above the water surface were in place and stable. The bank and topsoil backfill around the disturbed root systems of the leaner trees were stabilized with erosion control mats and there was evidence of some persistent grass and forb seedlings emerging from the Fall 2003 seeding.

The trees exhibited a flush of early growth from primary and secondary branches. There was minimal dieback of smaller branches during the dormant season near the tree branching system extremities. Some primary branches were cut or broken and damaged by anglers who attempted to open the overhanging structure and gain better access to surface water. At this time this damage does not appear to be life threatening to the tree. If this feature survives a second dormant season, it is expected that the tree will adjust

and continue to grow in its altered position. Maintenance of this feature includes periodic or annual removal of damaged branches that enter water to prevent debris buildup.

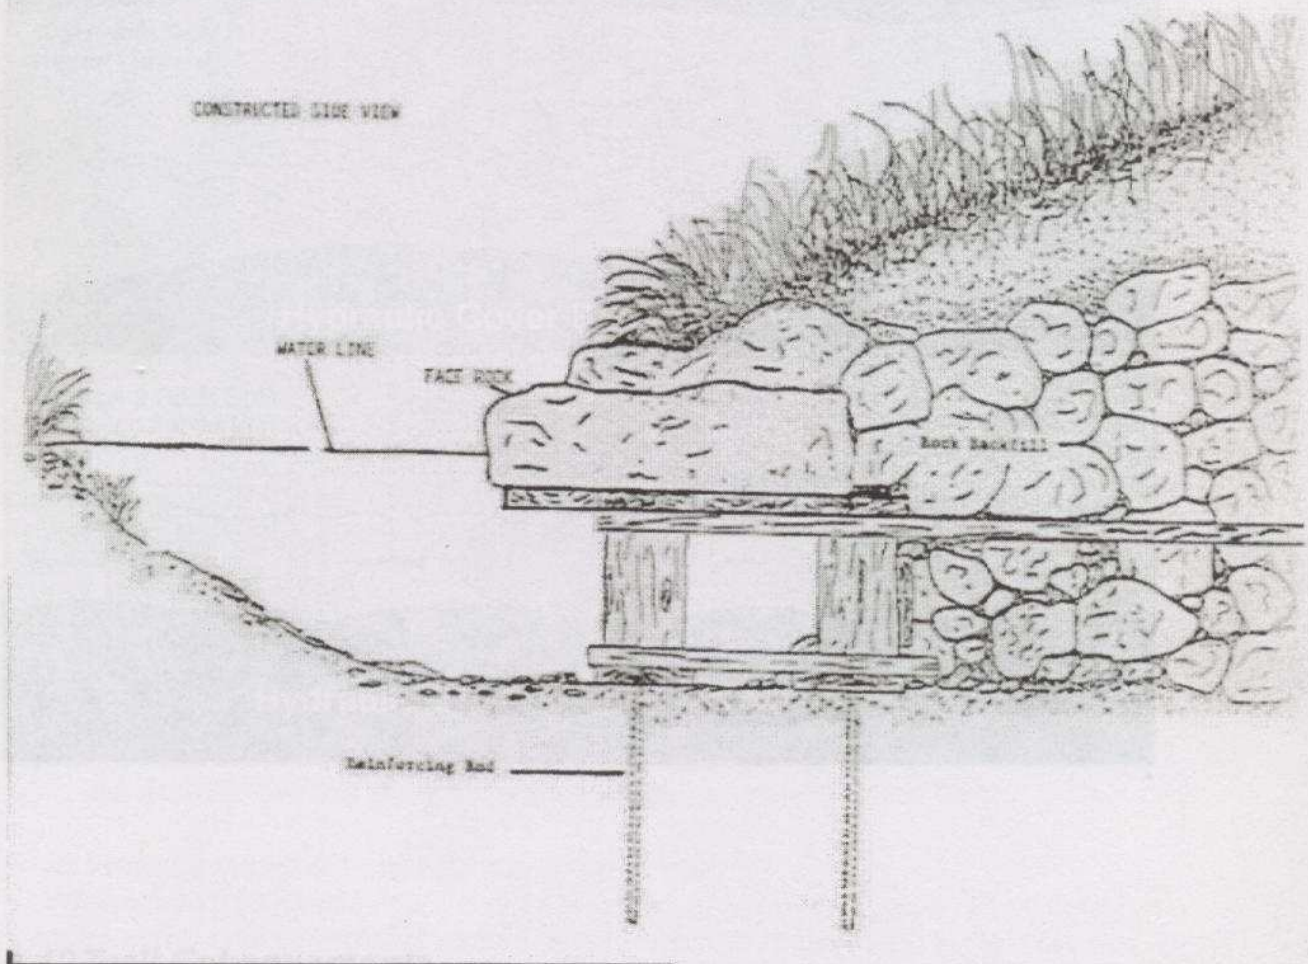
All LUNKERS were observed in the original placement and were completely submerged in the stream channel. Water was approximately the same level as at the time of construction in 2003. Minnows were observed inside the LUNKER cavities. Flow and velocity was adequate to prevent sediment or debris buildup at the base of the cavity.

July 13, 2004

All LUNKER structures were observed to be in place. Water level 6 inch higher than observed at time of the May 12 inspection.
