PHASE 1 RECONNAISSANCE SURVEY

Eighteenmile Creek Area of Concern

Niagara County, New York

Remedial Investigation/Feasibility Study

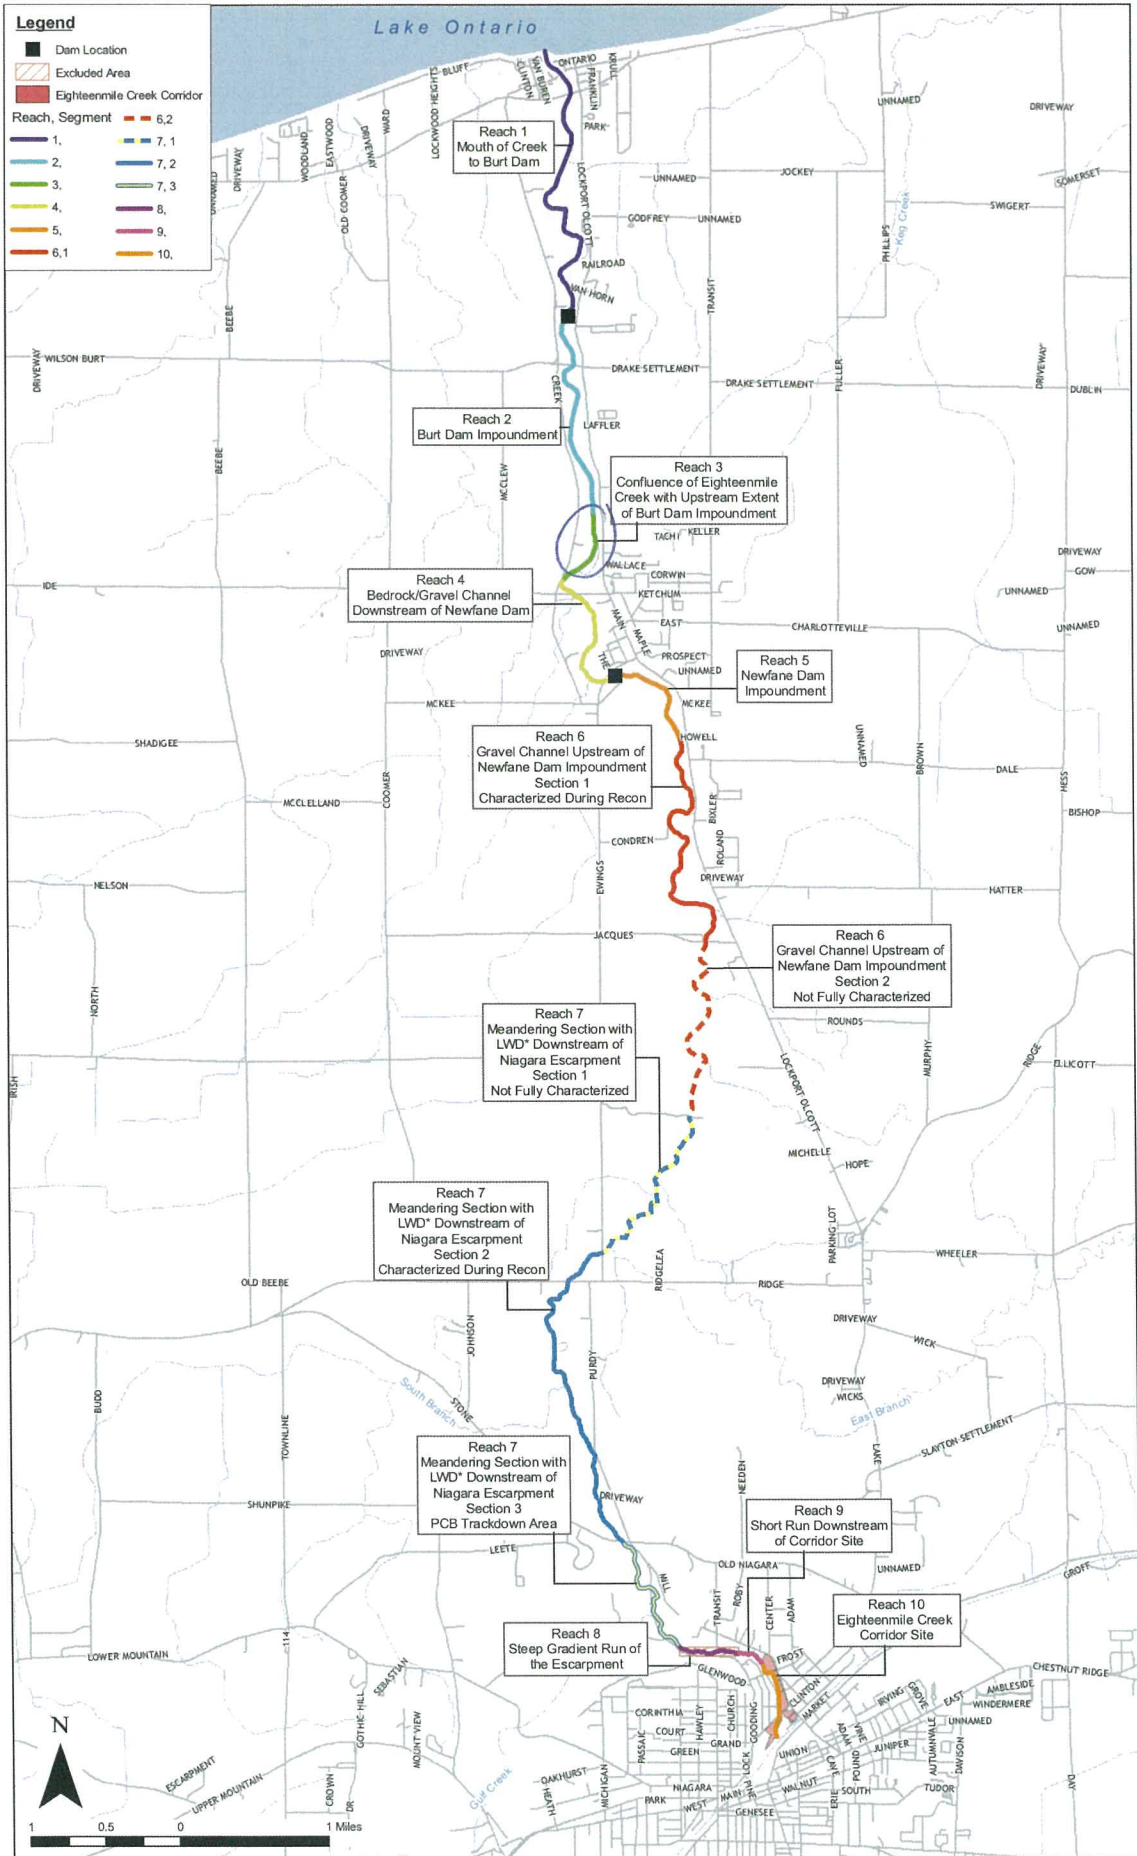
Figure 2-1 Eighteenmile Creek AOC and Investigation Areas

The results of the Phase 1 survey were used to define reaches of the creek based on the overall physical and channel substrate characteristics. These reaches are shown in Figure 2-1 and summarized on Table 2-1.

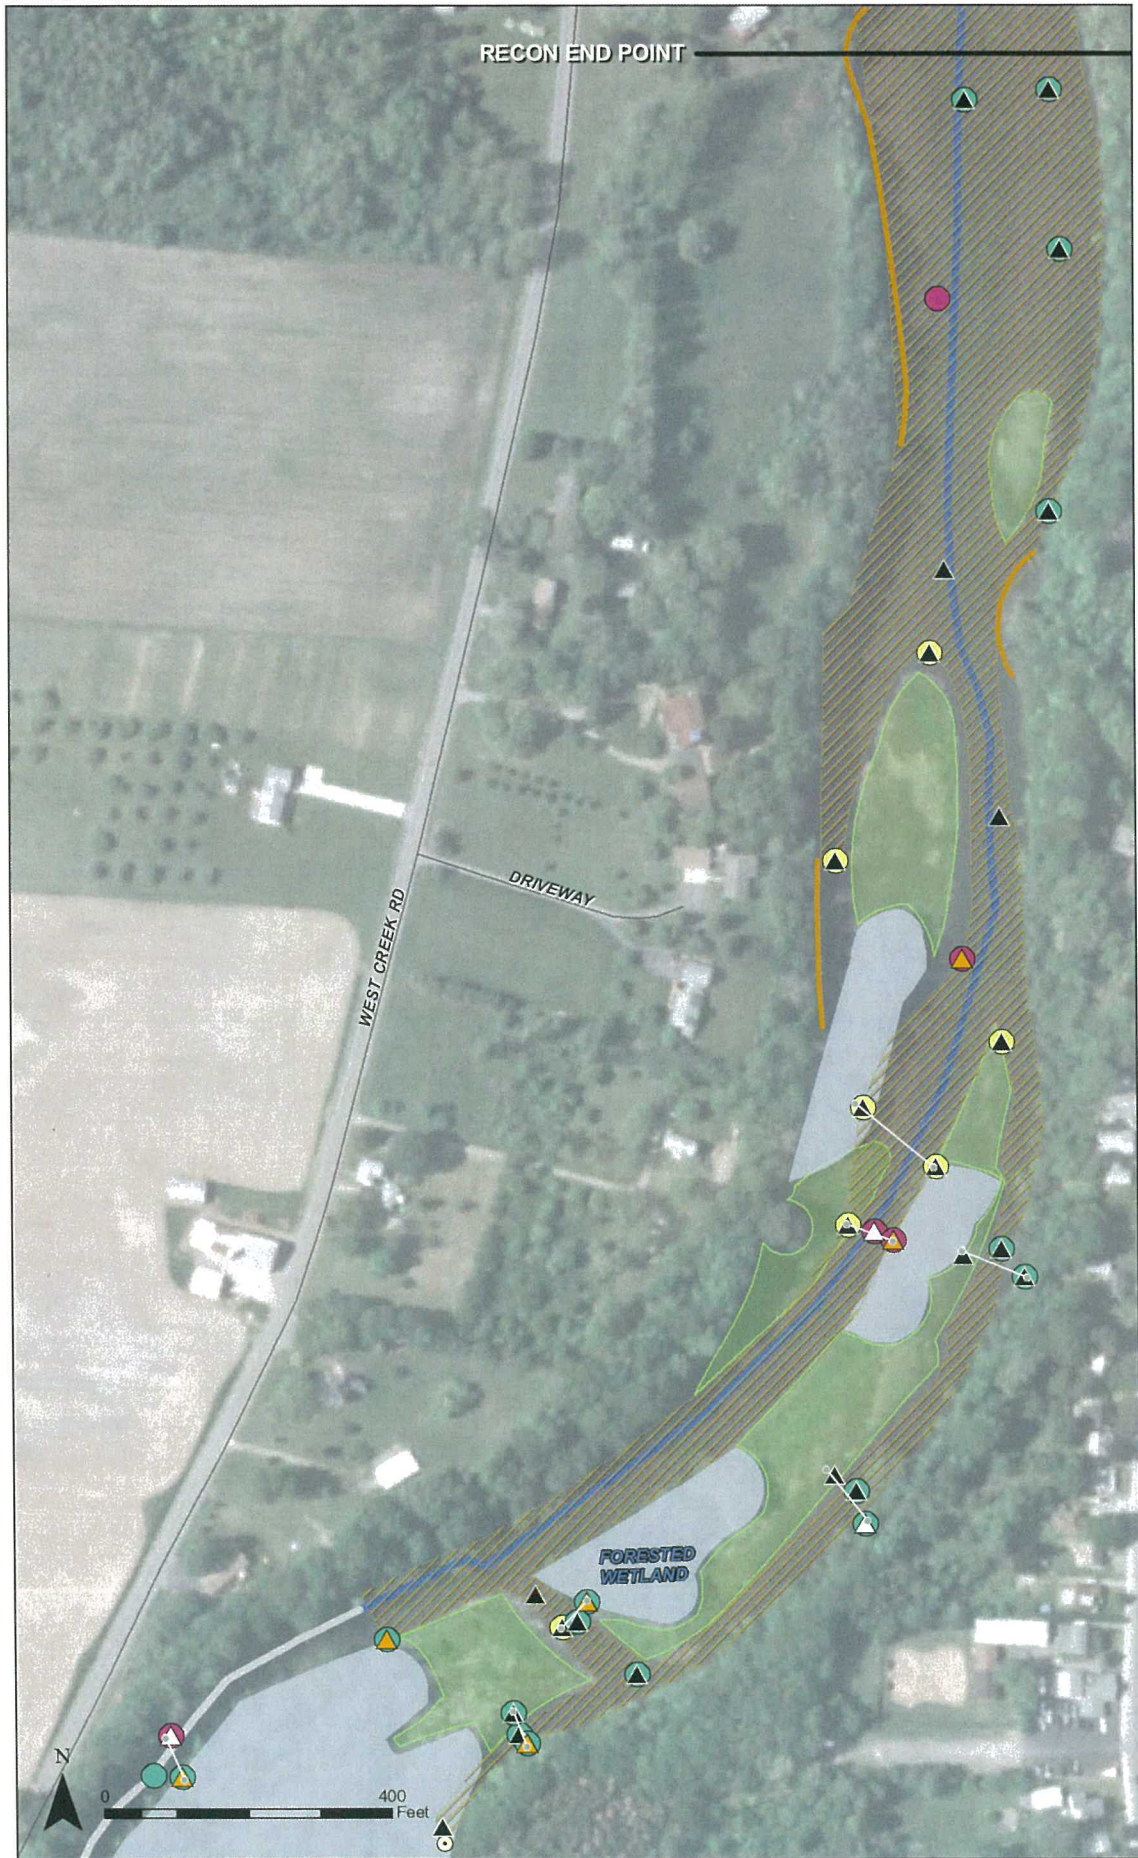
Figure 3-1 Reach 3
 Eighteenmile Creek Field Reconnaissance,
 Fall 2008 and Spring 2009, Niagara County, New York

Figure 3-1 and a portion of Figure 3-2 summarize the reconnaissance survey results for Reach 3. This reach is representative of a flooded stream bed with the meander of the original stream bed channel evident among islands of forested wetland and cattail marsh. The stretch is approximately 0.5 miles upstream of the deeper water of the Burt Dam impoundment (see Reach 2 on Figure 2-1). The sediment reconnaissance survey was completed on May 2, 2009. Two sediment thickness points also were probed in areas that fall within Reach 2 as shown on Table 3-1. The sediment probes indicate the deeper water in this reach is characterized by average sediment thickness of about 9 feet and relatively shallow water (less than 2 feet). Reach 2 area will also be characterized as part of the bathymetric survey.

The upstream portion of Reach 3 is characterized by a gravel bottom with swift flow and few sediment deposition areas. From SED 181 (Figure A-3-2) to the ending point of the reconnaissance survey at a point just south of the Burt Impoundment, the creek is characterized by large, deep sediment deposits due to the entrance of slack water. This lower portion has forested wetlands and cattail marsh along both banks with a mix of steep sloped sides and low floodplains. Sediment is primarily comprised of silt with fine sand, and some clay, with sediment depths generally greater than 3 feet and water depths less than 3 feet. A total of 31 sediment thickness and water depth points were collected in this area (see Table 3-1). Table 3-2 shows that total sediment depositional area was estimated at 9.75 acres with an additional 1.3 acres identified in what is Reach 2. There are several areas which are notable within this section of the creek:

- Two drainage locations were identified on either side of the creek near Ide Road.
- An inlet with some flow into the creek near SED 176 and SED 177 has sediment deposition with depths up to almost 2 feet (Figure A-3-2).
- From SED 181 to the survey end, sediment is deep throughout the entire creek. Sediment depths range from 1 foot to up to 10 feet. Additional deposition occurs along the entire length of the cattail marshes (Figures A-3-1, -2).
- A secondary (slough-like) channel along the east side of the creek valley is connected to the main stem of the creek by a small channel that runs between cattail marsh and wetland areas. This secondary channel also contains sediment, with depths from above 3 feet to almost 5 feet. Sediment depths within the connection channel range from just above 2 feet to over 5 feet (Figure A-3-2).

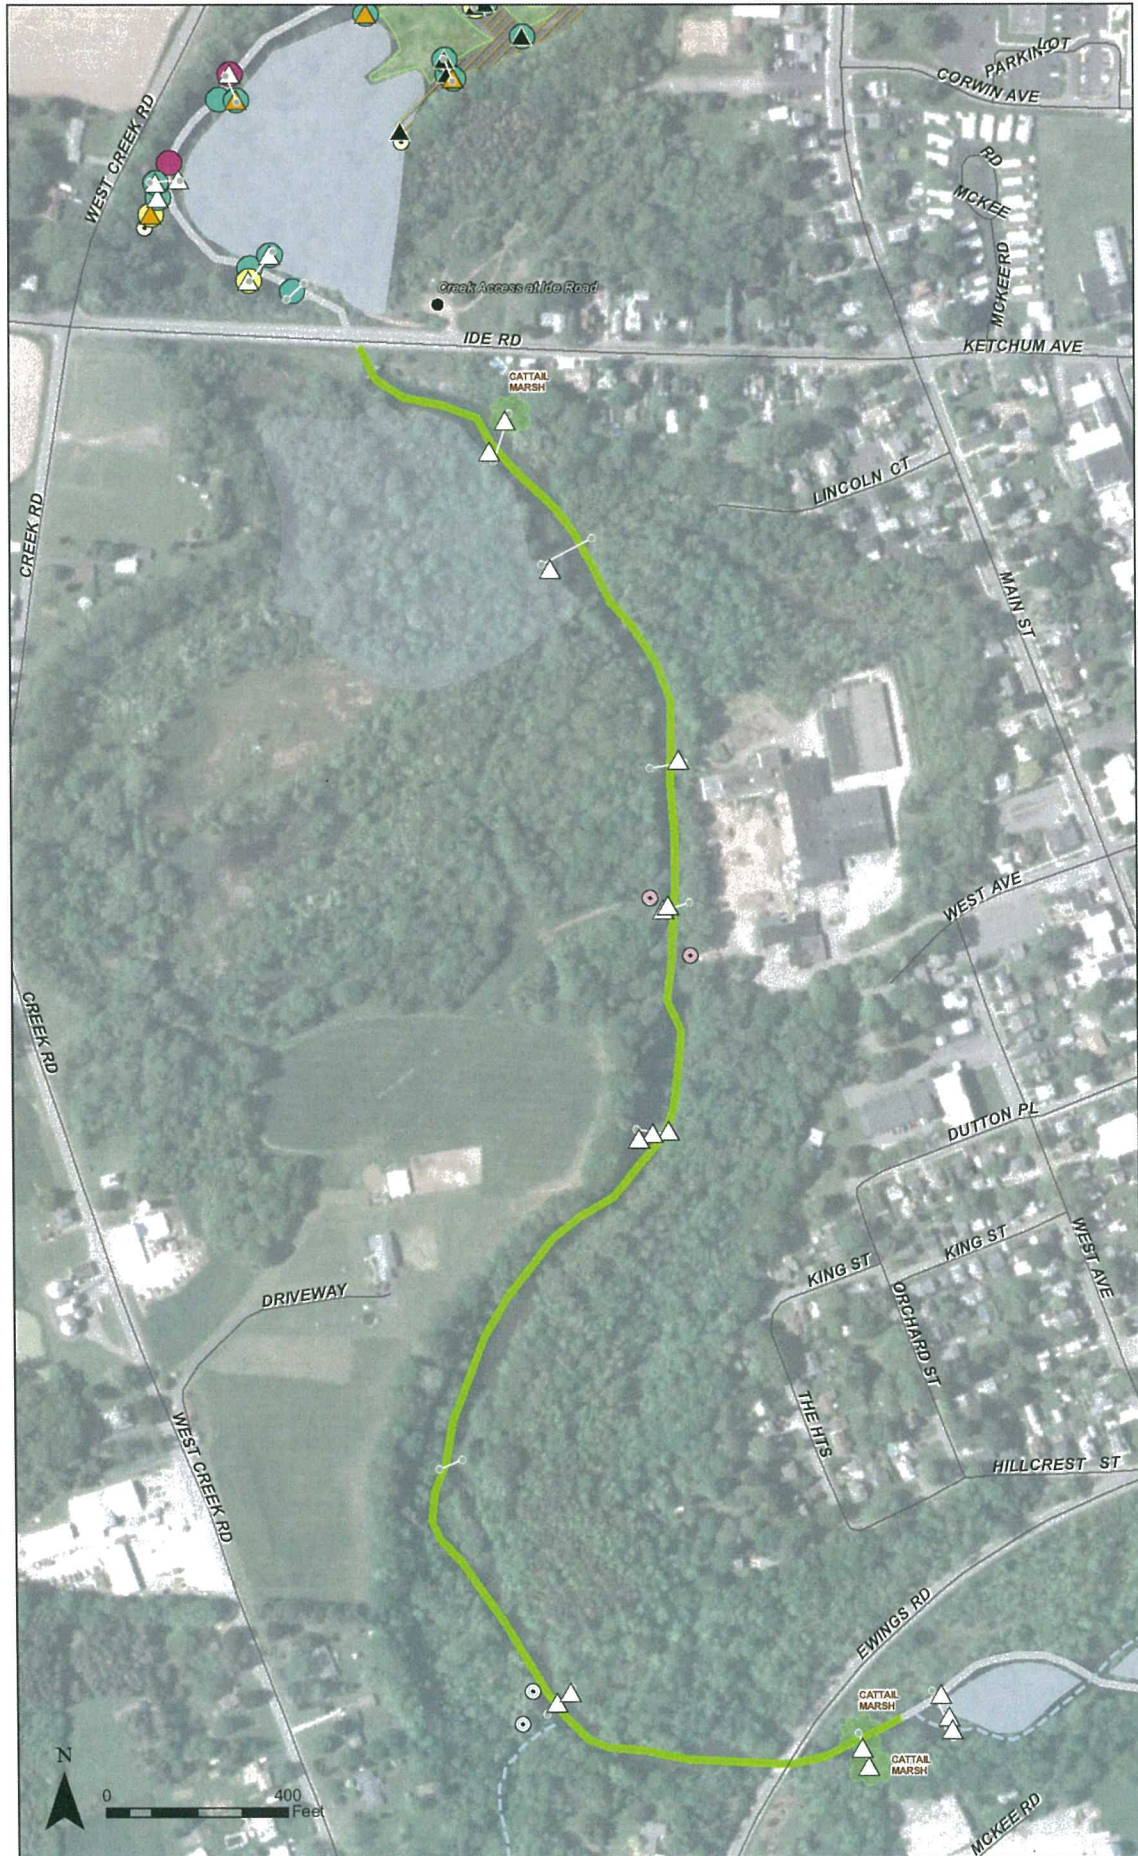
Figure 3-2 Reach 4
 Eighteenmile Creek Field Reconnaissance,
 Fall 2008 and Spring 2009, Niagara County, New York

Figure 3-2 summarizes the Reach 4 reconnaissance survey results for the portion of stream downstream of Newfane Dam to Ide Road. This reach is about 1 mile long and is influenced by the flow from Newfane Dam. It appears there are at least two locations along this stretch that had historic water withdrawal structures that influenced the channel and left obstructions in the creek. The survey reconnaissance effort was completed between the point immediately downstream of Newfane Dam to Ide Road on December 4 (see Figures A-1-2 to -4 and A-3-2 to -4). EEEPC encountered David Eaton, who owns the property next to Newfane Dam. He was

Reach 4 is characterized by relatively swift stream flows and fewer, shallower sediment depositional areas. Of the 22 sediment measurement points recorded, 13 exhibited sediment accumulations with an average sediment depth of 0.5 feet. The water was shallow with a depth of (generally less than 3.5 feet at all locations) with an average depth of 1 foot. Two channels depart from the dam (Photos P30 to P32); outflow from an old pump house structure along right side (Photo P56), and spillway overflow from left side. These conditions created an island over time of approximately 600 feet in length with a small, high water overflow channel reconnecting the two channels. Stream banks are 1 to 4 feet high with slopes of varying steepness that rise onto a floodplain bench. Stormwater enters the creek at the bridge at Ewings Road which contains roadside drainage pipes, and from non-point run-off along rip rapped stream banks.

Between Ewings Road North and Ide Road, areas of sediment deposits were shallow. This portion of the creek contains bedrock substrate within the main channel and was stripped of any sediment with the exception of the immediate vicinity of the banks. In these locations, less than 0.5 feet of sand, gravel, and organic material had accumulated, but it is likely that this material would be prone to washing out during higher flow events. Water depth between Ewings Road North and Ide Road (Figures A-3-2 and 3-3) was variable (0.25 feet to greater than 3.5 feet) and the flow was swift. Two small island features with right and left channels can be found along this stretch, the first is located approximately 600 feet downstream from the Ewings Road bridge. This island creates a small rapid adjacent to it that is choked with fallen trees and branches and not navigable by canoe (see P65A). Giant Hogweed was observed on this island. The second island is located 300 feet upstream from the Ide Road bridge and is defined by a giant willow that is split which has created a pond area that flushes during high water flow. A concrete structure along the west bank is situated upstream from the only tributary observed entering the

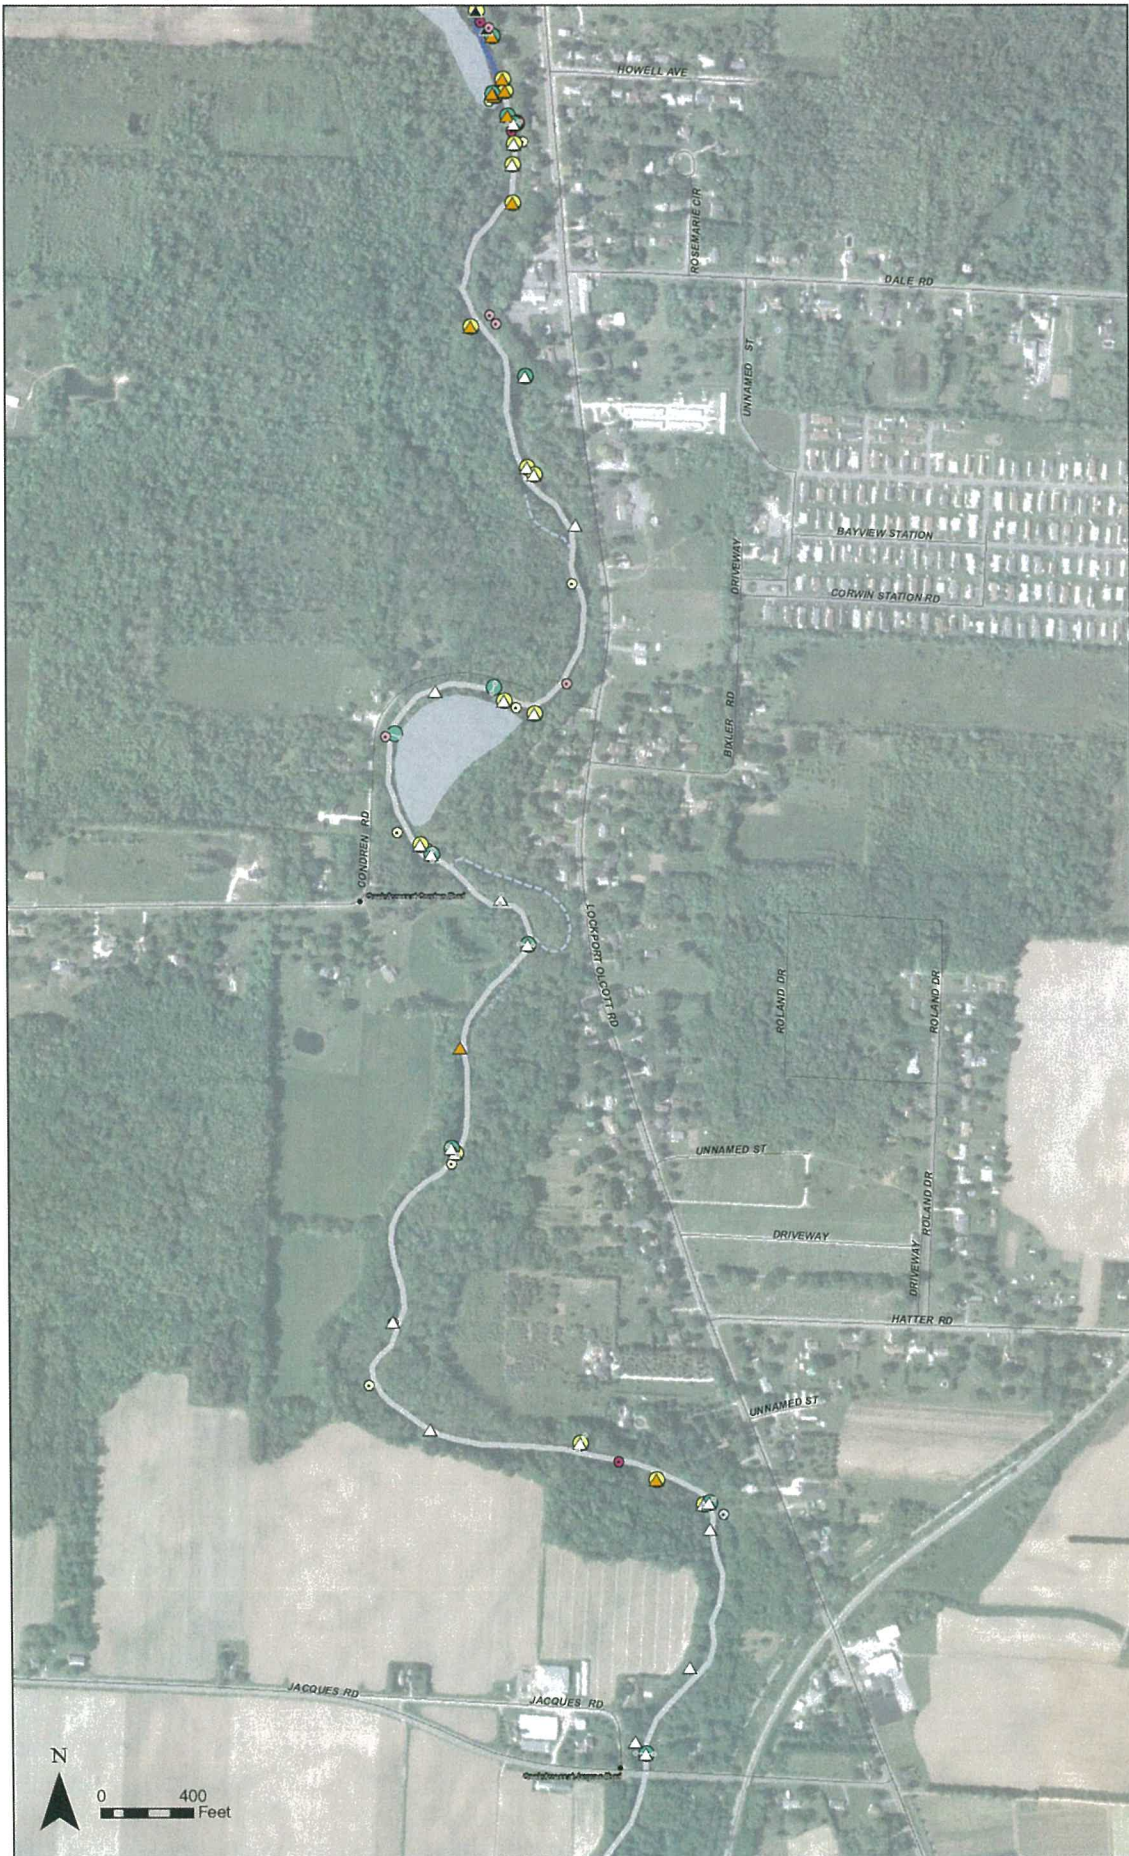
Figure 3-4 Reach 6, Segment 1
 Eighteenmile Creek Field Reconnaissance,
 Fall 2008 and Spring 2009, Niagara County, New York

Reach 6 is upstream of the Newfane Dam impoundment and is characterized by a gravel channel with scattered and shallow sediment deposition. The reach was divided into two sections based on the survey efforts. Section 1 was fully characterized during the Phase 1 survey and the results are summarized on Figure 3-4. Section 2 was part of the area from Ewings Road South to

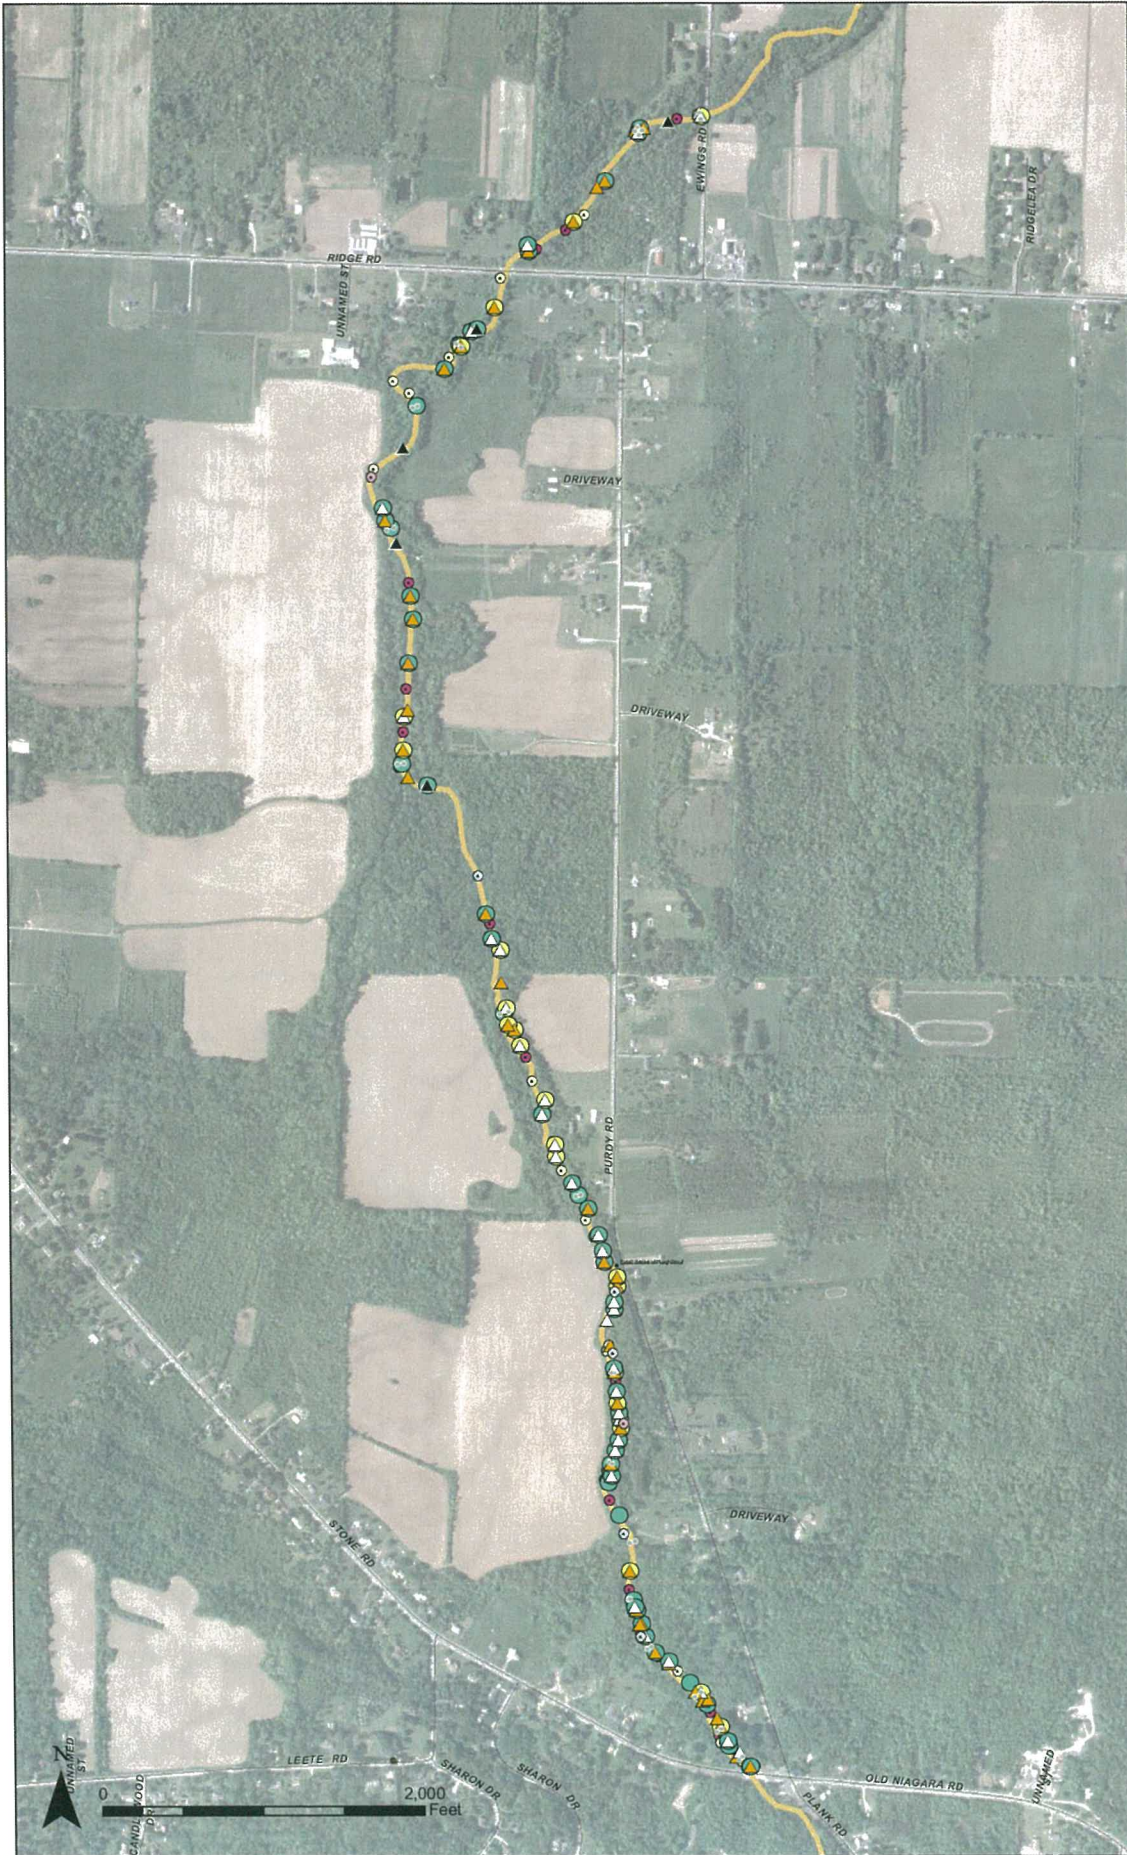
Figure 3-5 Reach 7, Segment 2
 Eighteenmile Creek Field Reconnaissance,
 Fall 2008 and Spring 2009, Niagara County, New York

Ridge Road, sediment becomes more of sandy silt with increased clay content within sediment pockets. Additionally, an increased frequency of cobble and some boulder were observed. In the lower portions of this sampling reach a number of forested wetlands were observed within floodplain. Visual observation indicates that overbank flooding occurs in many of these areas. It is also likely that drainage from agricultural fields beyond the riparian corridor also flows into the floodplains and wetlands. Points of discharge where overland drainages meet the creek were noted and mapped.
