**Eighteenmile Creek Restoration Project
Town of Newfane
Niagara County, New York**

**FINAL
Restoration Monitoring Plan for the
Eighteenmile Creek Habitat Restoration
Project**

May 3, 2005

Prepared By:
Ecology & Environment, Inc.

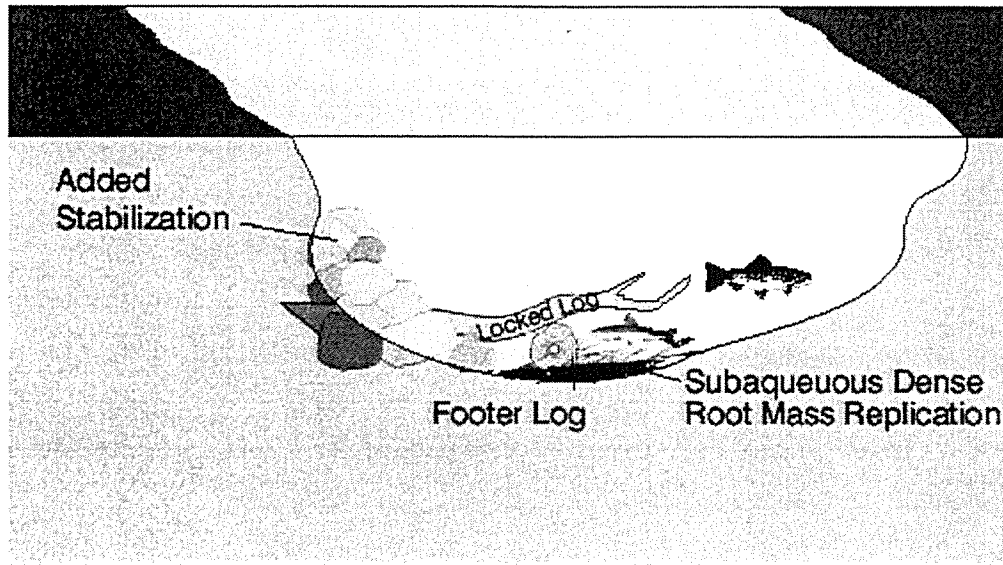
Locked Limbs/Logs with Footer Log and Subaqueous Dense Root Mass Replication

All locked logs were intact and functioning as constructed. The subsurface bank with stone stabilization was in the constructed position. The stabilized locked log had collected some submerged plant and small woody debris, but appeared to be functioning properly. There was no obvious alteration of flow beyond a slight reduction of velocity with a calm water zone near the base of the locked log. Small fish were observed in this area, indicating that this restoration measure was functioning as designed.

All structures were intact and functioning as constructed. Some water celery grass was observed growing in substrate below the locked logs and foliage approximately 18" long was flowing with current above log structure forming a vegetative curtain. No small fish were observed. However, given that the structures remained in place and aquatic vegetation was growing adjacent to the structures, this restoration measure was still providing adequate function to diversify the aquatic habitat.

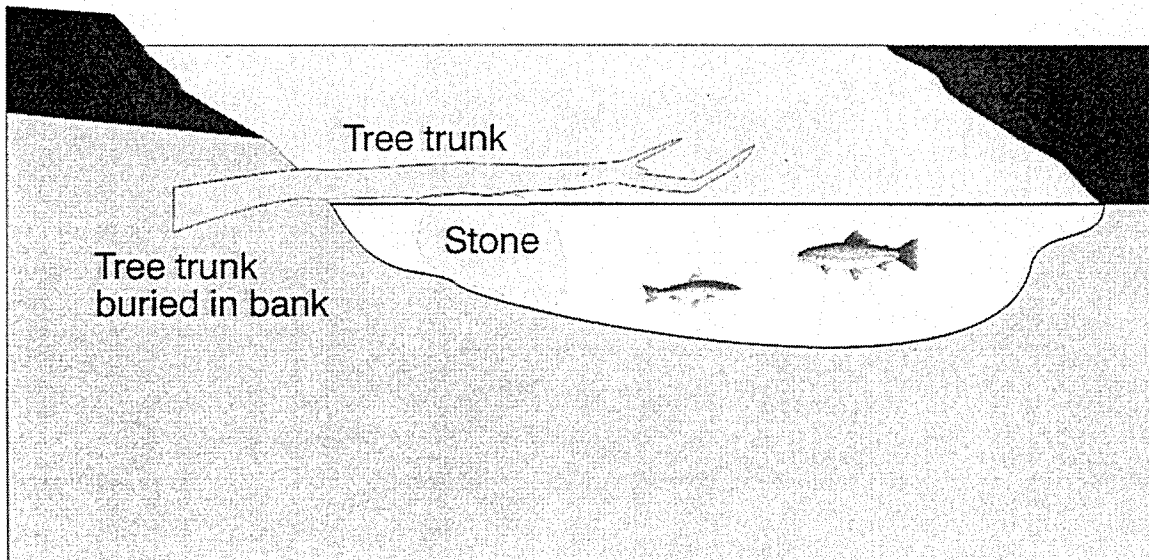
Extreme Instant Shade with Footer Stone

The Extreme Instant Shade cut poles were in place above the water surface in the constructed position. The bank at the point of insertion was firm and stabilized with erosion control mats. Erosion control grasses seeded in Fall 2003 were damaged and non-existent in some places in this area due to heavy foot traffic from anglers. The tree poles exhibited abundant new growth along portions of the trunk. Some sprouts and foliage were damaged from anglers walking or sitting on the horizontal poles, but the poles were functioning as designed.

Extreme Instant Shade poles were in their original position. New growth was sparse and it appears that many sprouts visible on May 11 were damaged or missing. All poles were alive but exhibited approximately 50% less foliage than was observed 60 days earlier. Continued monitoring of the extreme instant shade trees will occur to determine if the potential death of the tree would compromise bank stability. If signs of bank instability occur, the trees will be removed or cut and additional erosion control mats and seeding will occur to stabilize the banks.

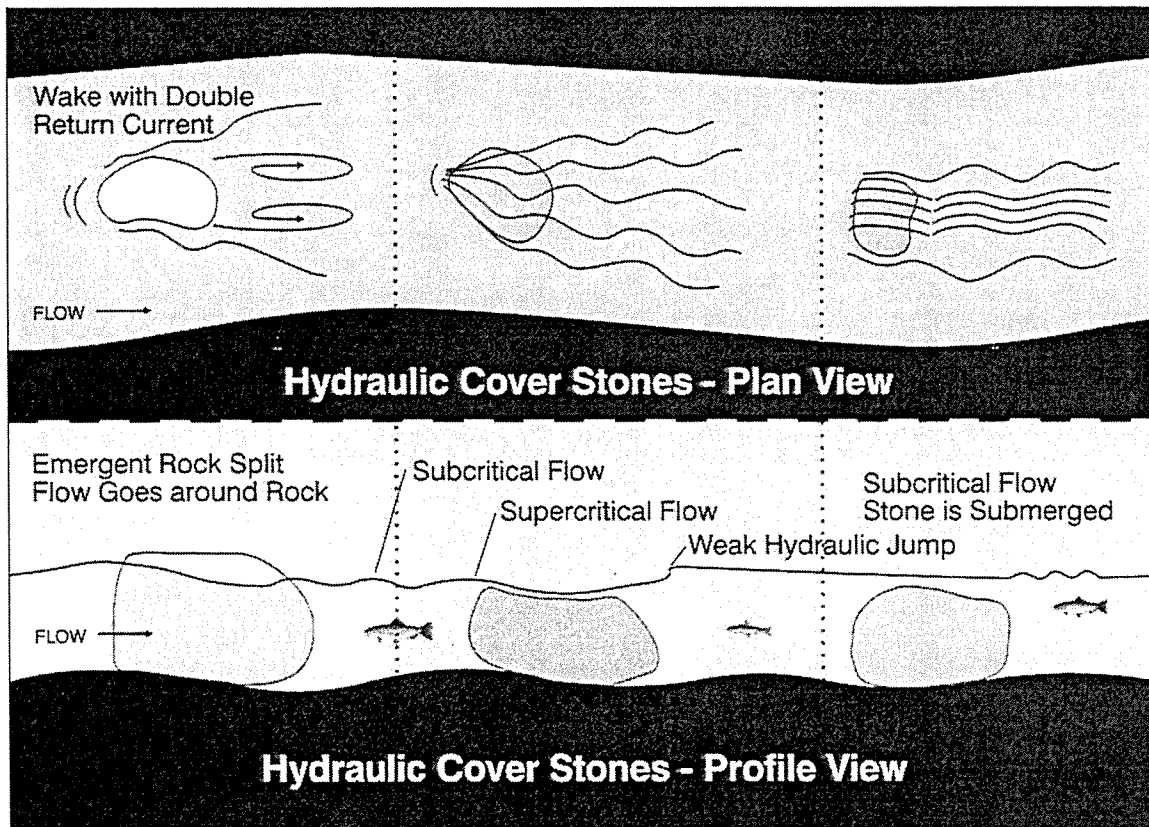
3.11 Hydraulic Cover Stones

All Hydraulic Cover Stones were observed in the approximate original placement and were partially submerged in the stream channel. The cover stones were providing hydraulic surface cover and were functioning as designed.

All Hydraulic Cover Stones were observed in the approximate original placement and were almost completely submerged in the stream channel. The cover stones were providing hydraulic surface cover and were functioning as designed. Based on these two site visits, the Hydraulic Cover Stones were functioning as designed. Similar to the LUNKERS, actual surveys of these areas would involve the use of more sophisticated

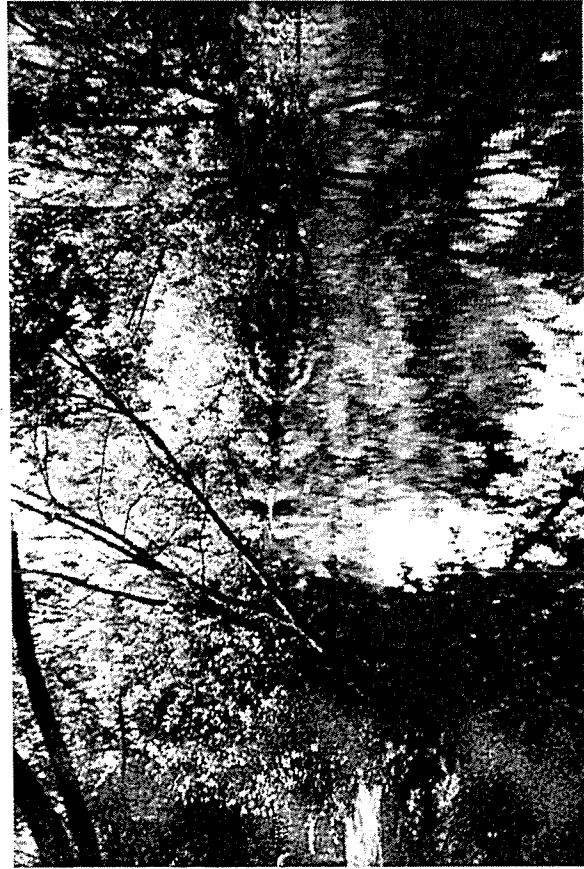
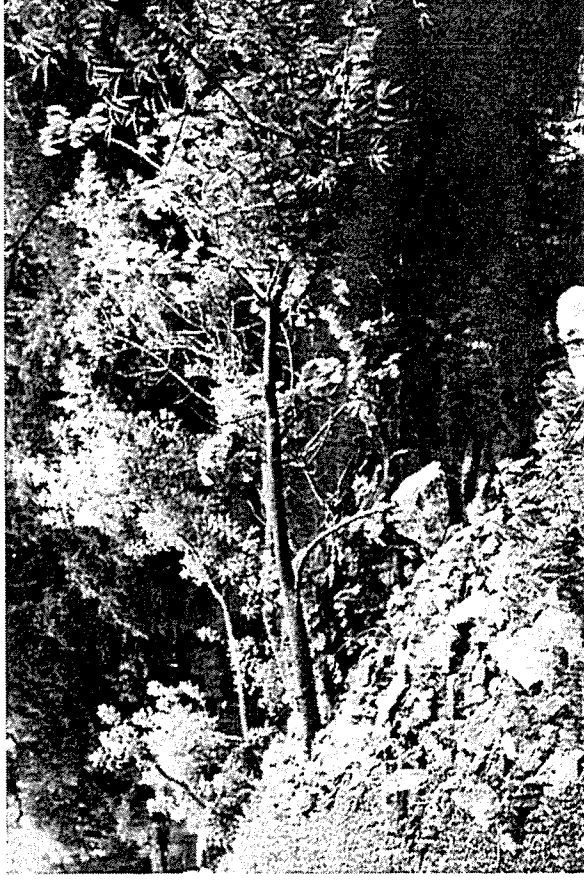
The leaner trees (*Acer negundo* – box elder) Instant Shade features were observed to be in place as positioned during construction. Bolster stones to support trees in an upright angle above the water surface were in place and stable. The bank and topsoil backfill around the disturbed root systems of the leaner trees were stabilized with erosion control mats and there was evidence of some persistent grass and forb seedlings emerging from the Fall 2003 seeding.

The trees exhibited a flush of early growth from primary and secondary branches. There was minimal dieback of smaller branches during the dormant season near the tree branching system extremities. Some primary branches were cut or broken and damaged by anglers who attempted to open the overhanging structure and gain better access to surface water. At this time this damage does not appear to be life threatening to the tree. If this feature survives a second dormant season, it is expected that the tree will adjust and continue to grow in its altered position. Maintenance of this feature includes periodic or annual removal of damaged branches that enter water to prevent debris buildup.

Leaner Trees/Instant Shade features were intact and functioning as constructed. Tree trunks were suspended over the water surface at the level that was designed during construction. Foliage was abundant and healthy from primary and secondary branches. Northern water snakes were observed basking on the portions of tree trunks that provide full sun exposure. Thus, the instant shade features were functioning as designed and enhancing the aquatic habitat conditions in the creek (i.e. providing additional shading of the creek channel).

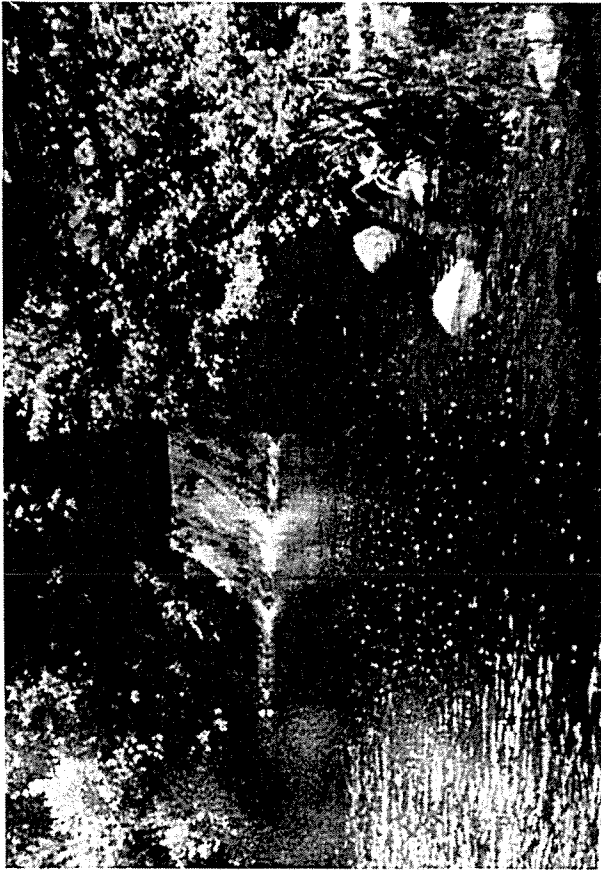
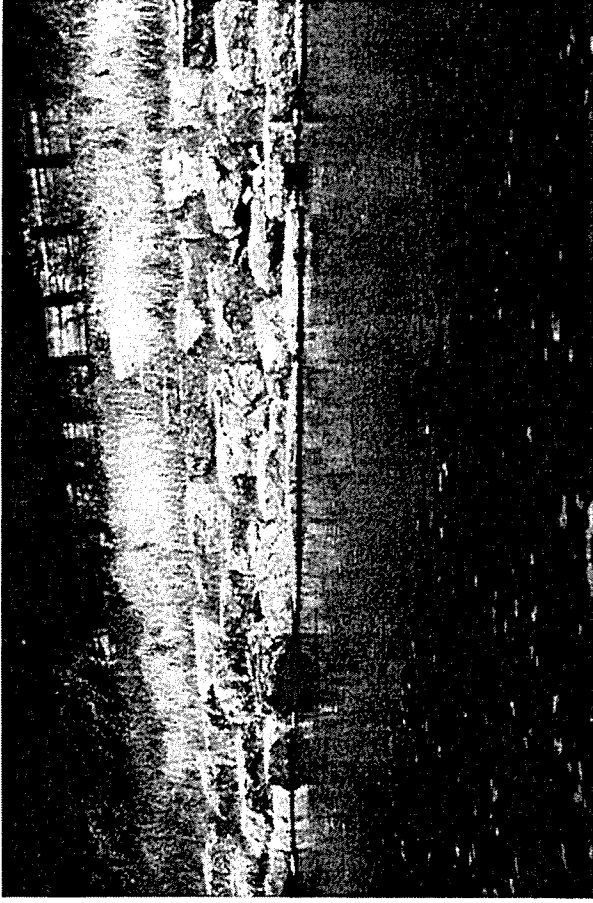
Stepped Wall Cavity Planting

The stepped wall construction was in place and stable. No evidence of settling, shifting or movement of the stone-wall or substrate foundation was evident. There was some minor settling of the soil-choked interstices. Some cavities had settled over six inches but most all had receded only a few inches. This was an expected condition due to the limited ability to compact the soil mix used to fill the voids in the wall.

The stepped stone wall was stable and in place. No shifting or movement was observed. All interstices that settled were filled with soil and seeded as necessary. All plantings except in high traffic areas were healthy and growing well. High traffic areas will be modified by placement of shrub islands or large stone barriers to modify traffic patterns and direct visitors to established trail sections. Based on these two site visits, the stepped wall was functioning as designed. The stepped wall provided access to the thousands of fishermen which use the area, as well as maintained stability of the bank in a severely eroded section.

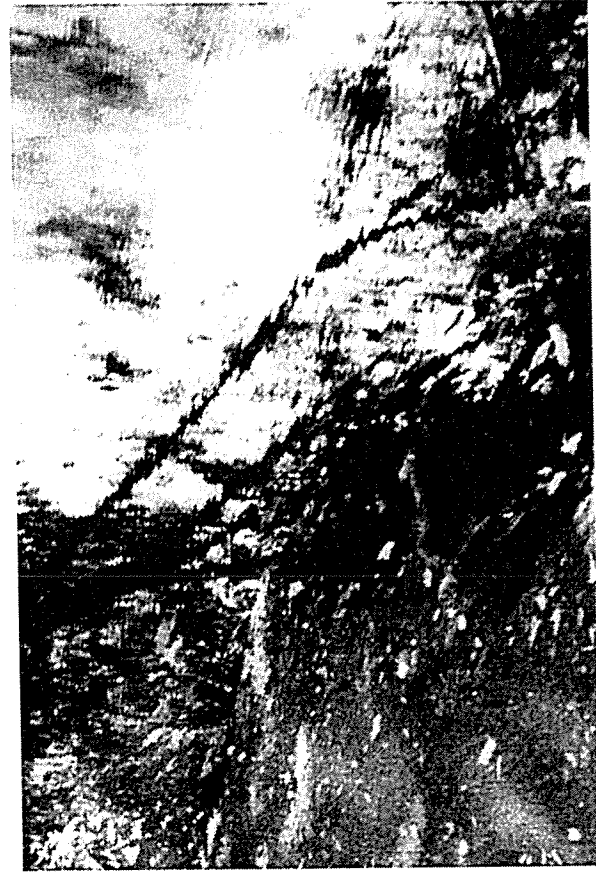
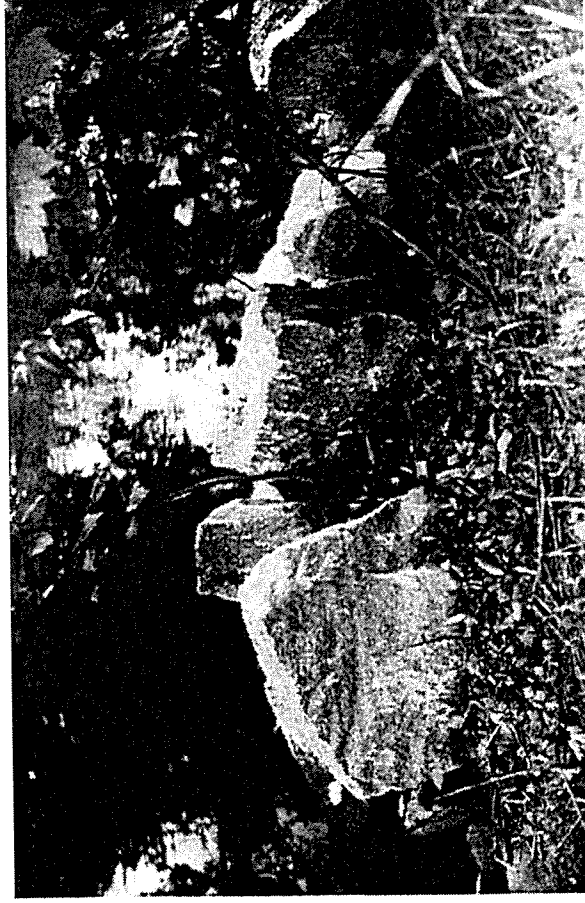
Modified Rip-Rap Planting

All riprap placed stone features were in place and stable. All erosion control blankets in disturbed soil areas around placed riprap were in place and functioning. All cavity or interstitial plantings were healthy and appeared to have over-wintered well. Some fringe shrub plantings and seeded areas were vandalized or damaged by visitors presumably to get better access to water, but the overall stability of the banks in these areas was intact.

All placed riprap was in place and stable. Some detritus and waterborne organic debris was deposited on riprap at water's edge. Species recruitment was evident by seedlings growing in algae and organic matter deposits. Additional soil was added to placed riprap cavities. Damaged plants and seeded areas exhibited new growth due to the lack of visitor pressure during the warm season. Based on these two site visits, the placed rock riprap was functioning as designed. The banks in these areas were stable and additional vegetation growth in these areas was evident, thus these structures were intact and functioning as designed (i.e. the stability of the streambank in the areas was improved).
