EIGHTEENMILE CREEK RESTORATION PROJECT: BASELINE HABITAT CHARACTERIZATION AND THREATENED AND ENDANGERED SPECIES COORDINATION

Prepared For:
Niagara County Department of Planning,
Development and Tourism
January 2003

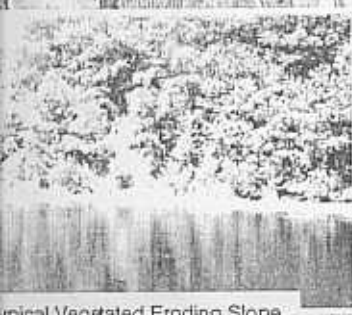
Typical Vegetated Eroding Slope

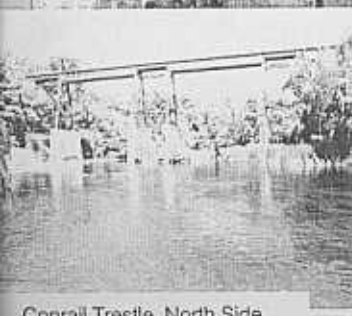
Conrail Trestle, North Side

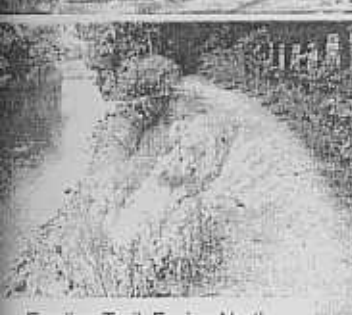
Eroding Trail, Facing North

In the recent past, a steep slope trail from the parking lot area provided the only public access to the creek and trail to Burt Dam. The parking area is approximately 60 ft above the stream bank (Figure 2). Stairs recently installed provide safer access for the public, especially during inclement weather. It was observed that most fishermen accessing the site continue to use the slope trail next to the stairs. A slope drainage system has been installed below the soil surface adjacent to stairway to convey storm water, which will provide a degree of erosion control for the exposed slope surface.

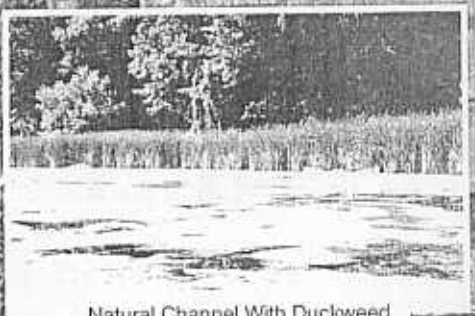
Natural Channel With Duckweed

The aquatic habitat in CR 2 consists of high quality warm water fish habitat. Aquatic vegetation was abundant and various structures are present; this section is also characterized by variable depths. The aquatic vegetation community was dominated by water celery, although other species observed included: Elodea (*Elodea canadensis*), Sago pondweed (*Potamogeton pectinatus*), curly pondweed (*Potamogeton crispus*), leafy pondweed (*Potamogeton foliosus*), longleaf pondweed (*Potamogeton nodosus*), water milfoil (*Myriophyllum spicatum*), coontail (*Ceratophyllum demersum*), Chara (*Chara* sp.), and duckweed (*Lemna* sp.). Macrophyte growth was observed as generally increasing in total cover and density as the creek flows downstream. There are clumps and small beds that emerge and become more common at the end of CR 1, but become much more abundant and pervasive in CR 2. From the end of CR 1 to the downstream project limit, the total cover of aquatic vegetation was estimated to range from 5% - 70%. The backwater areas behind the cattail islands and the channel side of some of these islands were observed as containing dense beds and mats of growth. The slackwater and backwater areas are almost completely covered with duckweed, with some locations exhibiting 100% cover.
