# Sampling Report

## Former Flintkote Plant Site 143 Water Street, City of Lockport, Niagara County, New York

New York State Department of Environmental Conservation Division of Environmental Remediation 270 Michigan Ave Buffalo, New York 14203-2999

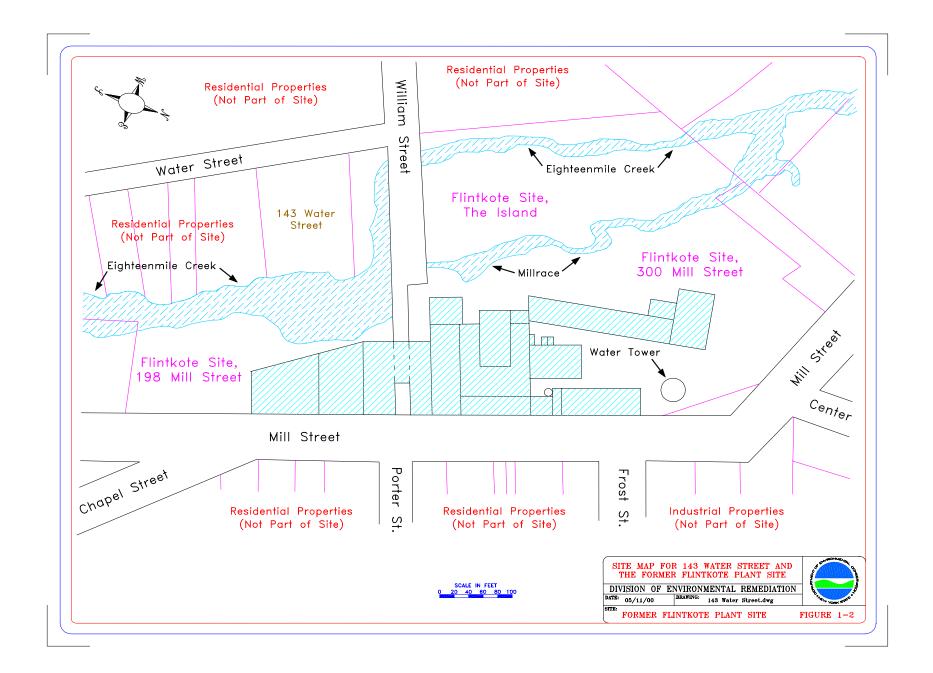
The Former Flintkote Plant consisted of property at 198, 225 and 300 Mill Street in the City of Lockport, Niagara County, New York (Figure 1-2). Only the property at 198 and 300 Mill Street, which occupies a total area of approximately 6 acres, was included in the Department's 1999 Site Investigation. The Site is bordered by Eighteenmile Creek to the west, Mill Street to the east, a commercial property to the north and vacant land to the south (Figure 1-2). The property was formerly operated as a felt and composite laminate plant, but is now vacant and in disrepair. Residential property is located west of the Site across Eighteenmile Creek and east of the Site across Mill Street. The Site is bisected by William Street (Figure 1-2), which divides the Site into north (300 Mill Street) and south portions (198 Mill Street). William Street is no longer open to vehicular traffic, but until recently when access was restricted, pedestrian use was common.

As shown on Figure 1-2, Eighteenmile Creek is diverted westward from its apparent natural course for approximately 300 feet along William Street by a dam approximately ten feet high. William Street is located on top of this dam. The creek then continues northward through cross-culverts beneath William Street to return to its original natural channel farther downstream. A pair of sluice gates are located at the east end of the dam and formerly allowed water from Eighteenmile Creek to enter a millrace. These sluice gates have been closed for at least twenty years. The millrace runs along the west side of the buildings at 300 Mill Street and empties into Eighteenmile Creek approximately 600 feet downstream (Figure 1-2). The millrace now contains a sluggish stream approximately six inches to one foot deep.

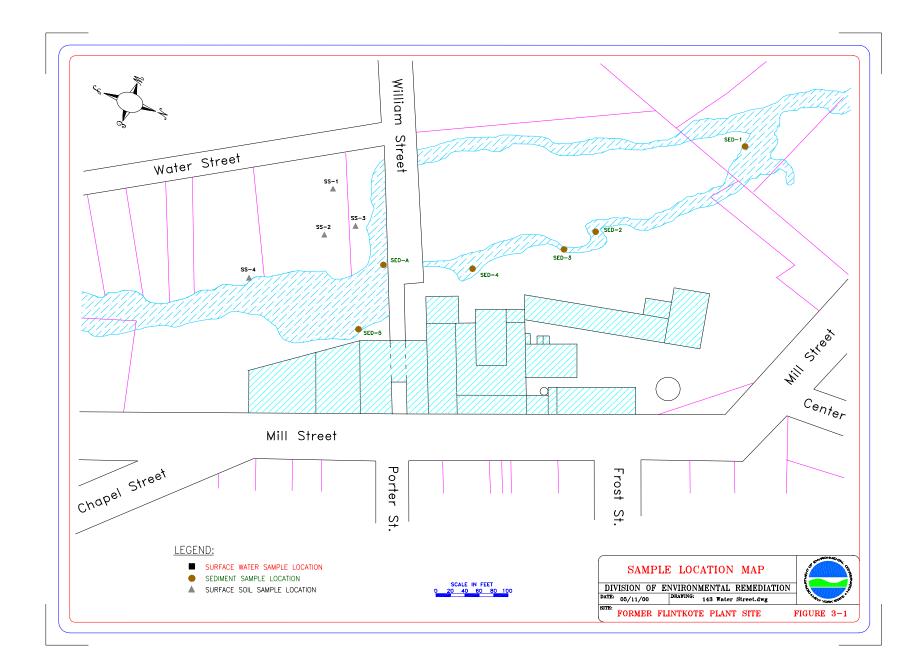
Prior to collecting any samples, a walk through of the property was conducted to identify sample locations. Four locations were selected. These locations, shown on Figure 3-1, were selected based upon visual observations or the potential for human exposure through direct contact or ingestion.

During the April 16<sup>th</sup> sampling event, one waste sample (SS-3 on Figure 3-1) was collected and submitted to Severn Trent Laboratories for chemical analysis of PCBs and lead. These contaminants were selected for analysis because PCBs are known to exist in Eighteenmile Creek sediment, while ash at the Former Flintkote Plant Site contains high concentrations of lead. Sample SS-3 was collected from the small ridge along Eighteenmile Creek, and consisted primarily of rust colored ash containing slag and buttons (Figure 5-1). This ash is similar in appearance to the ash observed on the island of the Former Flintkote Plant Site.

Three surface soil samples were also collected on April 16, 2002 and submitted to Severn Trent Laboratories for chemical analysis of PCBs and lead. The location of these samples (SS-1, SS-2 and SS-4) are shown on Figure 3-1. Sample SS-1 was collected from the portion of the side yard that floods during high water events (Figure 5-4). This area is at the end of a natural drainage swale to Eighteenmile Creek (Figure 5-5), and would be the first area to flood during high water events and the last area from which flood waters would recede. This sample consisted primarily of black topsoil with no visible evidence of waste material. The analytical results for this sample are shown in Table 5-1, and indicate that lead is present at a concentration of 887 mg/kg. While this concentration of lead exceeds the TAGM 4046 soil cleanup objective, it is similar to lead concentrations in other urban areas of western New York. PCBs were also detected in this sample at a concentration of 64J Fg/kg (parts per billion), which is below the 1,000 Fg/kg TAGM 4046 surface soil cleanup objective.

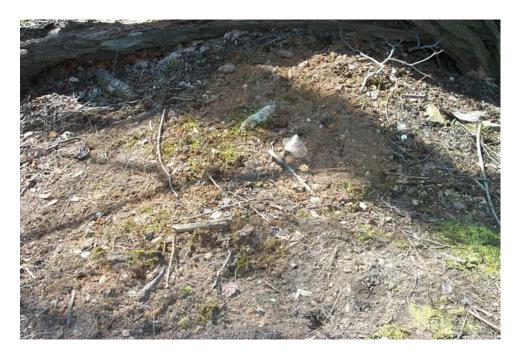
Prior to collecting any samples, a walk through of the property was conducted to identify sample locations. During this reconnaissance, ash fill (Figure 5-1) was observed at the surface of a small ridge along Eighteenmile Creek on a small strip of wooded property (Figure 5-2). Tax records indicate that this property is part of the former Flintkote property that is now owned by Niagara County. Extensive ash fill was also observed in the bank of Eighteenmile Creek (Figure 5-3).

Figure 5-1. Photograph of ash from a small ridge along Eighteenmile Creek. This area was the location of sample SS-3. Photograph taken by Paul Dicky on April 16, 2002.

The analytical results of the ash sample are shown in Table 5-1, and indicate that PCBs are not present in the waste. Lead, however, was detected at a concentration of 4,250 mg/kg (parts per million), a concentration that significantly exceeds the TAGM 4046 soil cleanup objective. Due to this high concentration of lead, the Department also decided to analyze the sample for lead using the Toxicity Characteristic Leaching Procedure (TCLP). The result from this analysis is shown in Table 5-1, and indicates that the ash is a characteristic hazardous waste for lead (D008).

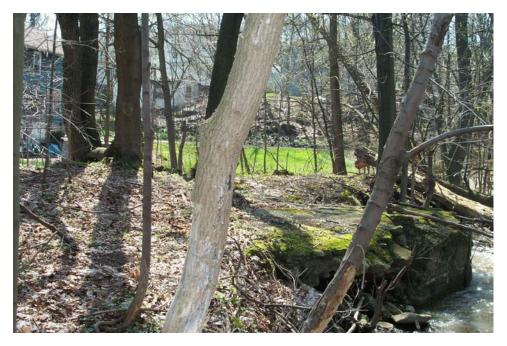
Figure 5-2. Photograph of the small ridge of ash fill along Eighteenmile Creek. The grassy area in the background is the side yard of the property at 143 Water Street. Photograph taken by Paul Dicky on April 16, 2002.

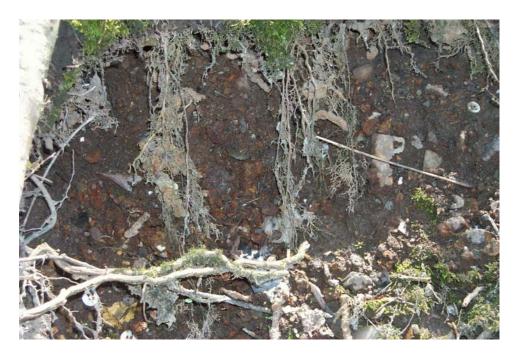
Figure 5-3. Photograph of ash fill in the creek bank along Eighteenmile Creek. Observe the buttons, which are characteristic of the ash fill on the island of the former Flintkote property. Photograph taken by Paul Dicky on April 16, 2002.

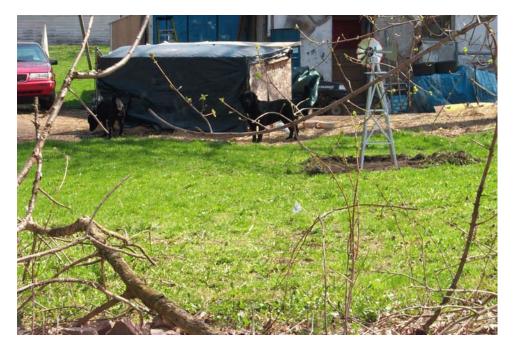
Figure 5-4. Photograph of sample location SS-1 (at white flag). This sample was collected from the side yard of 143 Water Street at the area that floods during high water events. Photograph taken by Paul Dicky on April 16, 2002.

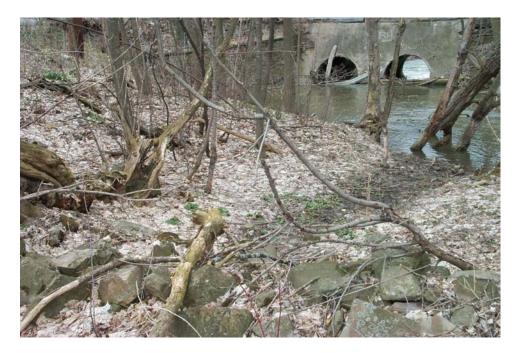
Figure 5-5. Photograph of the natural drainage swale from the side yard of 143 Water Street to Eighteenmile Creek. The cross-culverts beneath William Street can be observed in the background. Note the debris partially blocking these culverts. Photograph taken by Paul Dicky on April 16, 2002.

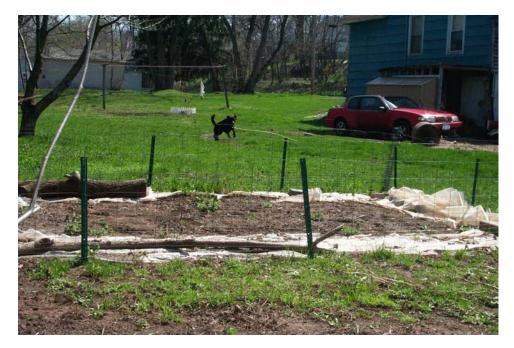
Sample SS-2 was collected from the center of a small vegetable garden in the side yard of the 143 Water Street property (Figure 5-6). This sample consisted primarily of medium brown soil with glass, buttons and coal fragments. The analytical results for this sample are shown in Table 5-1, and indicate that lead is present at a concentration of 686 mg/kg. This concentration of lead exceeds the TAGM 4046 soil cleanup

objective, but is similar to lead concentrations in other urban areas of western New York. PCBs were also detected in this sample, but at a concentration (24J Fg/kg) below the Department's TAGM 4046 surface soil cleanup objective.

Figure 5-6. Photograph of the small garden at 143 Water Street. Sample SS-2 was collected from the center of the garden. Photograph taken by Paul Dicky on April 16, 2002.

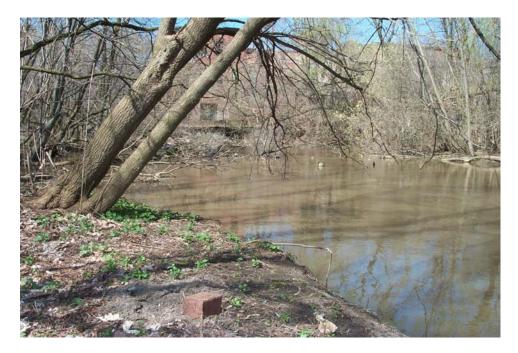
Figure 5-7. Photograph of sample location SS-4 (at the brick) along Eighteenmile Creek. The former Flintkote buildings can be observed in the background. Photograph taken by Paul Dicky on April 16, 2002.
