Division of Environmental Remediation

Sampling Report

Water Street Properties, City of Lockport, Niagara County, New York

March 2003

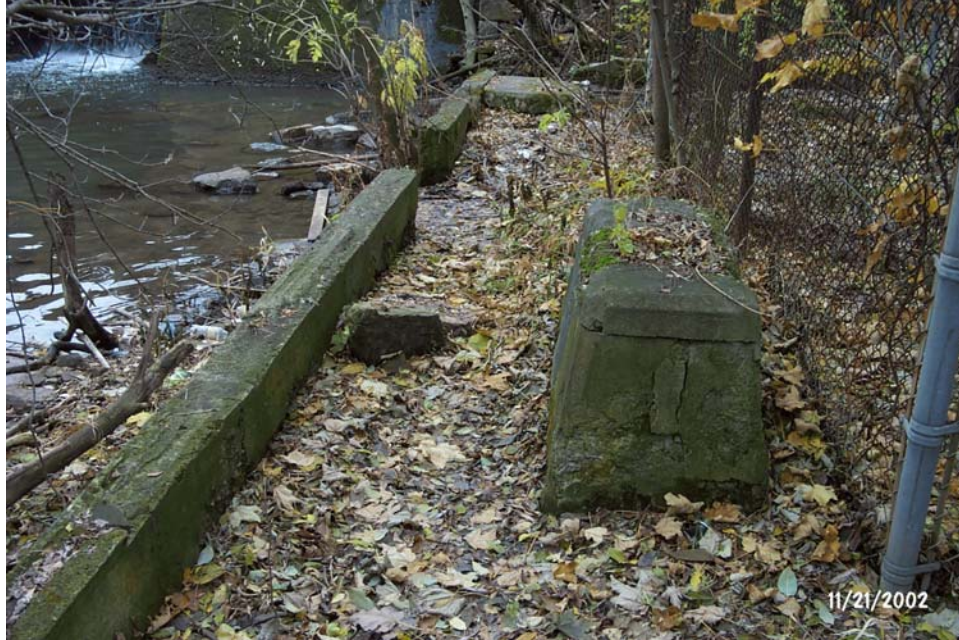
Figure 2-1. Photograph of the fenced containment structure that may have housed transformers and/or capacitors containing PCB oil. The Clinton Street dam is in the background, while Eighteenmile Creek is to the left. Photograph taken by Paul Dicky on November 21, 2002.

On November 7, 2002 during an inspection of Eighteenmile Creek to identify potential sampling locations, NYSDEC and NCHD personnel discovered a fenced containment structure downstream of the Clinton Street dam. This structure may have housed transformers and/or capacitors, which historically contained PCB oil. As a result, this area was identified as a potential source of PCBs to Eighteenmile Creek.

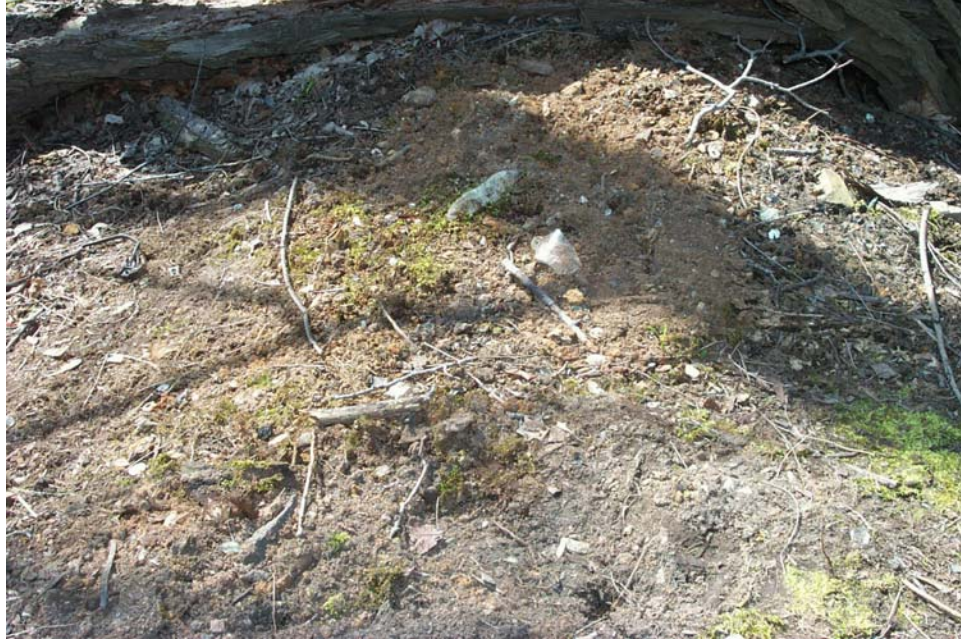
Prior to collecting any samples, a walk through of the property was conducted to identify sample locations. During this reconnaissance, ash fill (Figure 5-1) was observed at the surface of a small ridge along Eighteenmile Creek on a small strip of wooded property (Figure 5-2). Tax records indicate that this property is part of the former Flintkote property that is now owned by Niagara County. Extensive ash fill was also observed in the bank of Eighteenmile Creek (Figure 5-3).

Figure 5-1. Photograph of ash from a small ridge along Eighteenmile Creek. This area was the location of sample SS-3. Photograph taken by Paul Dicky on April 16, 2002.

Analytical results from an ash sample collected from the small ridge adjacent to the 143 Water Street property revealed the presence of lead at a concentration (4,250 mg/kg) that exceeded the Department's TAGM 4046 soil cleanup objective. This sample also exceeded the TCLP Regulatory Limit for lead, indicating that this ash is a characteristic hazardous waste (D008). This ash is similar in appearance to the ash observed on the island of the Former Flintkote Plant Site, which is also a characteristic hazardous waste for lead (D008). While surface water/solids runoff from this ridge to the 143 Water Street property may explain the relatively high concentrations of lead in surface soil samples SS-1 (shallow swale), SS-2 (garden), SS-11 (dog trail) and SS-12 (garden), this ash does not explain the high concentrations of lead detected at other Water Street properties. Also, the possible presence of ash fill in the garden at 143 Water Street, as suggested by the buttons, coal and glass that were observed, could explain the high concentration of lead in samples SS-2 and SS-12.

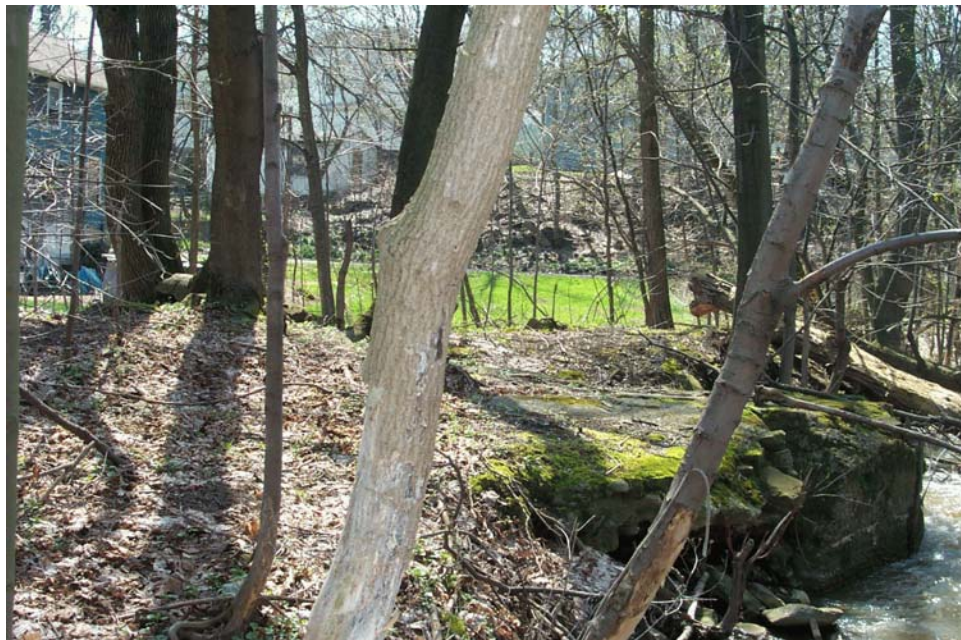
Figure 5-2. Photograph of the small ridge of ash fill along Eighteenmile Creek. The grassy area in the background is the side yard of the property at 143 Water Street. Photograph taken by Paul Dicky on April 16, 2002.

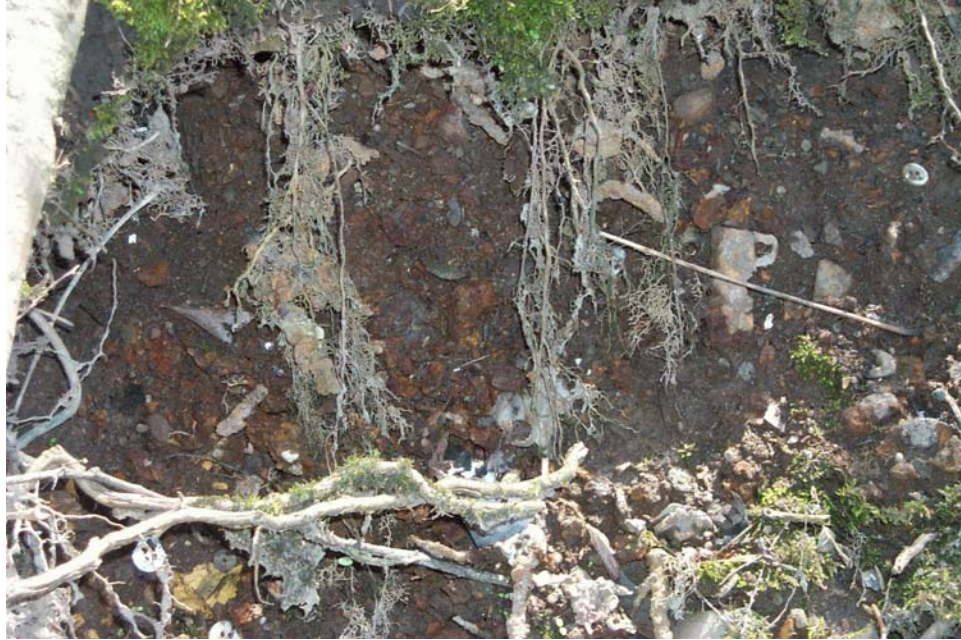
Figure 5-3. Photograph of ash fill in the creek bank along Eighteenmile Creek. Observe the buttons, which are characteristic of the ash fill on the island of the former Flintkote property. Photograph taken by Paul Dicky on April 16, 2002.

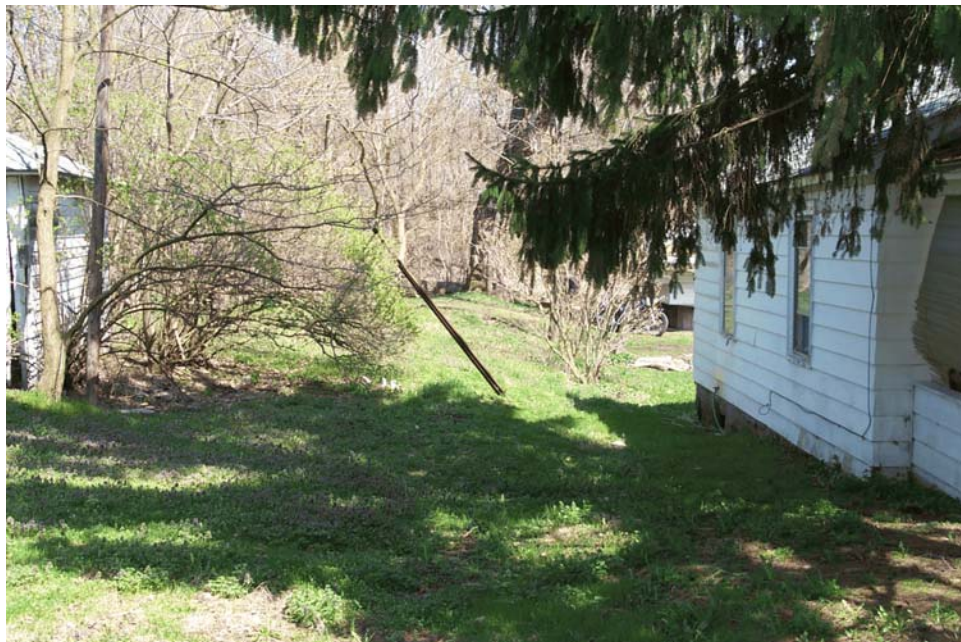
Figure 5-4. Photograph of the property line between 131 and 127 Water Street. The elevation difference (about 3 feet) delineates the extent of ash-cinder fill at the 143 and 131 Water Street properties. Photograph taken by Paul Dicky on April 16, 2002.

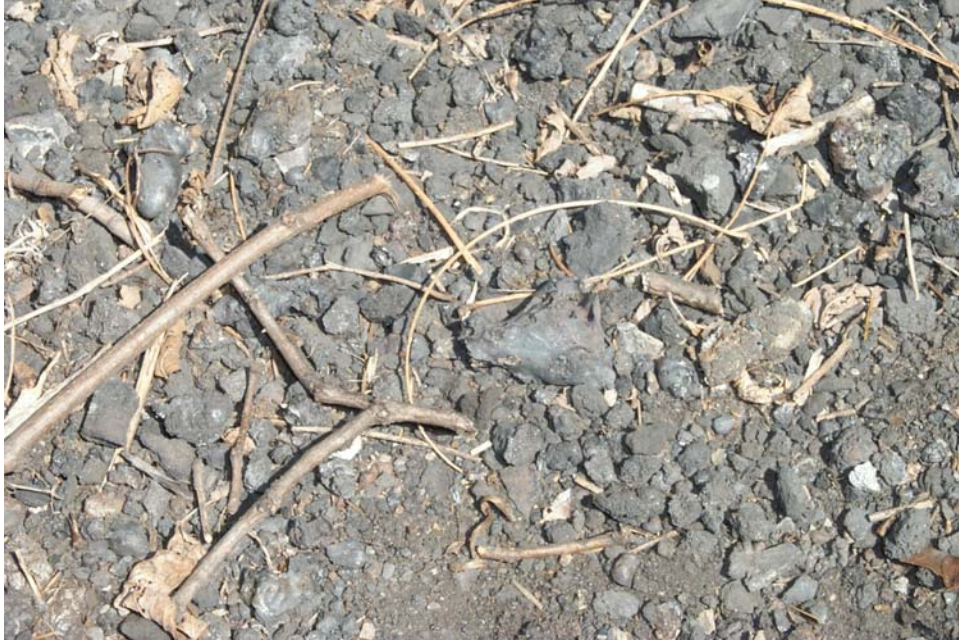
Figure 5-5. Photograph of the floor inside the garage at 131 Water Street. This ash-cinder fill is found throughout the mound shown in Figure 5-4. Photograph taken by Paul Dicky on April 16, 2002.

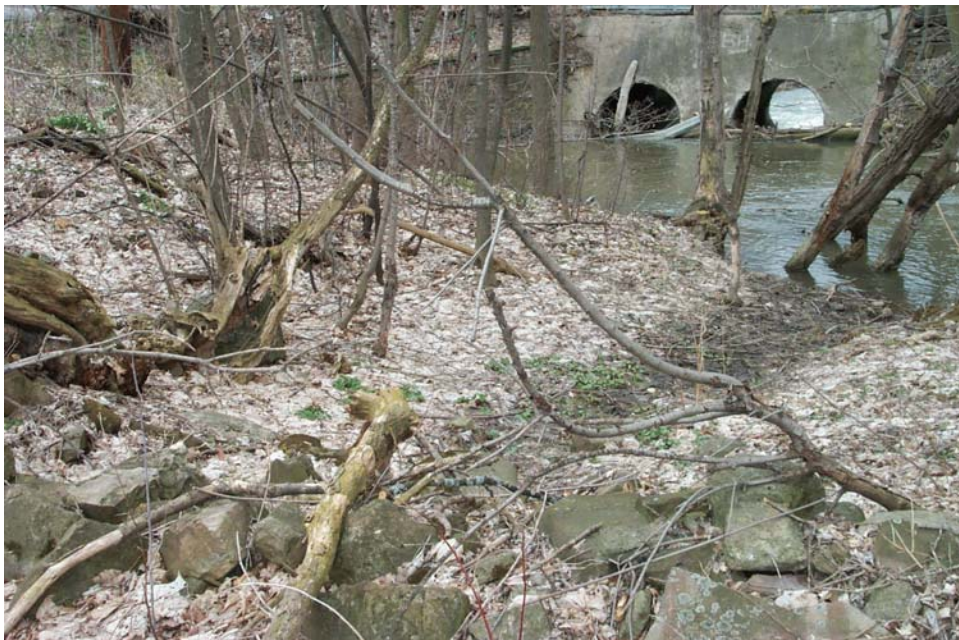
Figure 5-6. Photograph of the natural drainage swale from the side yard of 143 Water Street to Eighteenmile Creek. The cross-culverts beneath William Street can be observed in the background. Note the debris partially blocking these culverts. Photograph taken by Paul Dicky on April 16, 2002.

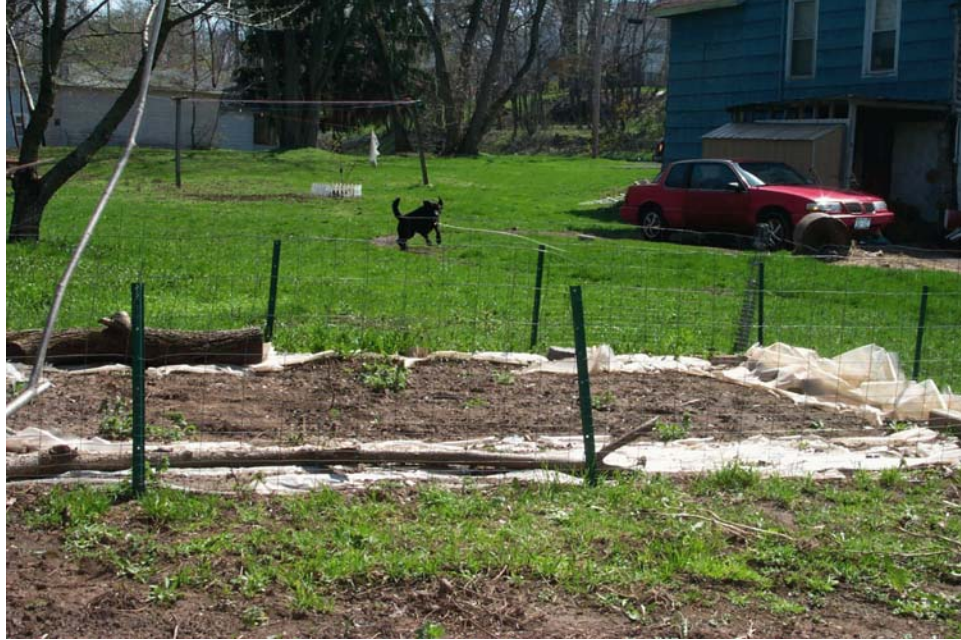
A small vegetable garden in the backyard was also inspected; buttons, coal and glass were observed. When asked, the property owners informed us that the garden was rototilled in place. The portion of the yard that floods during high water events was also identified.

Figure 5-7. Photograph of the small garden at 143 Water Street. Samples SS-2 and SS-12 were collected from the center of this garden. Photograph taken by Paul Dicky on April 16, 2002.

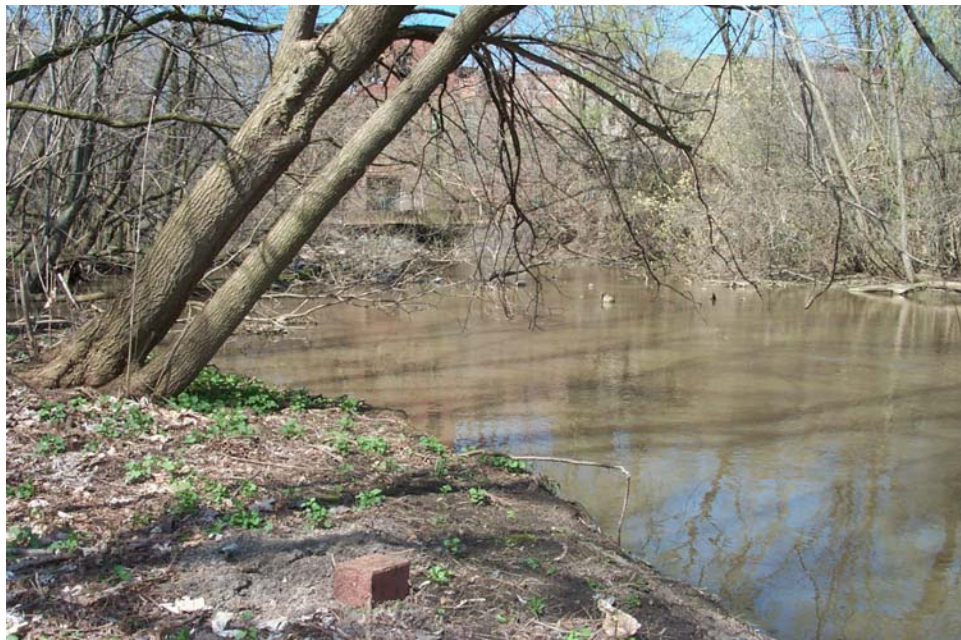
Figure 5-8. Photograph of sample location SS-4 and SS-8 (at the brick) along Eighteenmile Creek. The former Flintkote buildings can be observed in the background. Photograph taken by Paul Dicky on April 16, 2002.

were collected from low-lying flood prone areas. The lead in samples SS-8 (1,100 mg/kg) and SS-9 (1,360 mg/kg) was present at concentrations similar to that of sample SS-4 (1,270 mg/kg). The concentration of lead in nearby sample SS-10, however, was significantly higher at 4,630 mg/kg. While the reason for the high lead concentration in this sample is uncertain, it may be related to the shards of metal observed at the sample SS-10 location. The concentration of lead in sample SS-21 was also anomalously high (3,680 mg/kg), but so was the concentration of lead in Eighteenmile Creek sediment near this location (6,000 mg/kg).

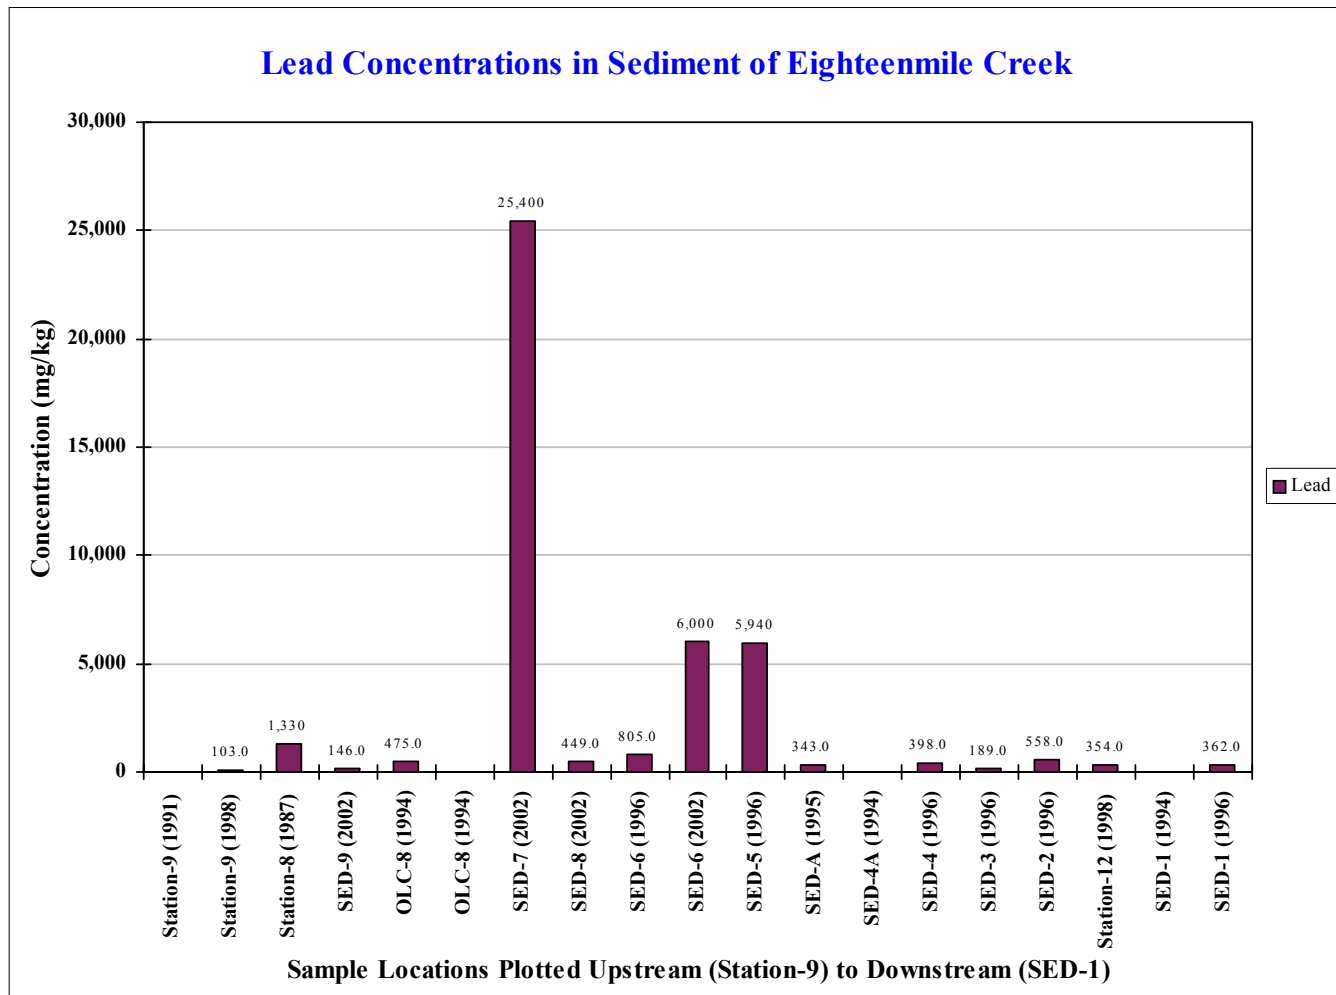
Figure 6-1. Lead concentrations in sediment of Eighteenmile Creek from Remick Parkway (Station-9) to the Former Flintkote Plant Site (SED-5 to SED-1).

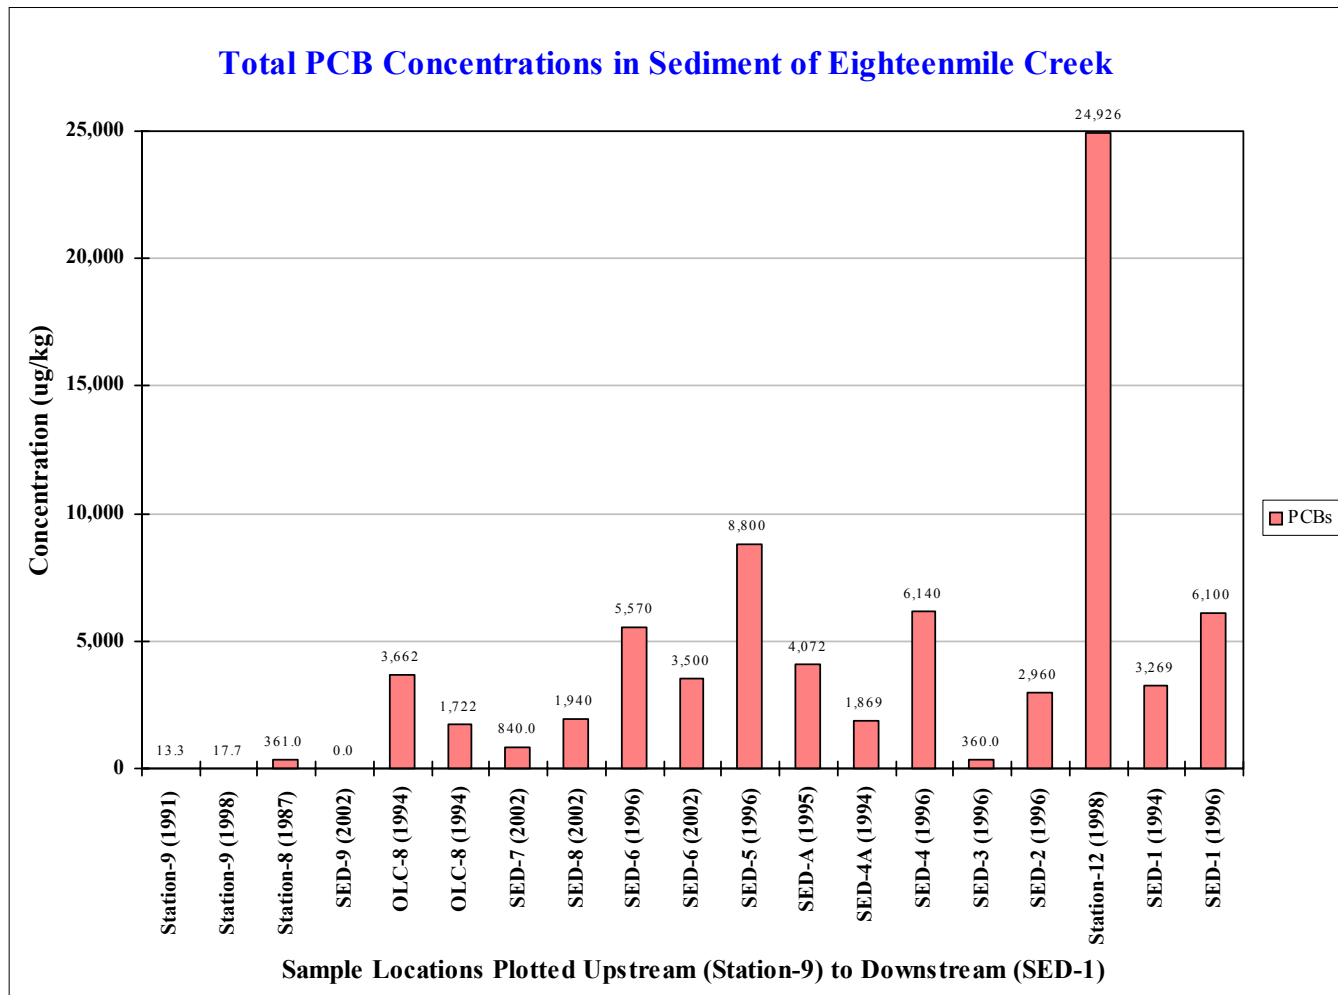
Upstream of the Clinton Street dam, PCB concentrations were relatively low, ranging from 13.3 to 361 Fg/kg. Immediately downstream of the dam, PCB concentrations increase substantially (840 to 3,662 Fg/kg), and remain elevated throughout the portion of Eighteenmile Creek evaluated in this study. These data suggest a source of PCBs near the Clinton Street dam. This source, however, does not appear to be the former transformer area or the extensive ash fill that was observed south of the Former Flintkote Plant Site. At this time the source remains unknown.

Figure 6-2. PCB concentrations in sediment of Eighteenmile Creek from Remick Parkway (Station-9) to the Former Flintkote Plant Site (SED-5 to SED-1).

The available analytical data suggest a source of PCBs near the Clinton Street dam; immediately downstream of the dam PCB concentrations increase substantially (840 to 3,662 mg/kg) and remain elevated throughout the portion of Eighteenmile Creek evaluated in this study. This source, however, does not appear to be the former transformer area or the extensive ash fill that was observed south of the Former Flintkote Plant Site. At this time the source remains unknown.
