RESULTS FROM THE SAMPLING OF ERIE CANAL SUSPENDED SEDIMENTS AND CREEK WATERS FOR PCBs

EIGHTEEN MILE CREEK CORRIDOR SITE

SITE No. 932123

OCTOBER 2010

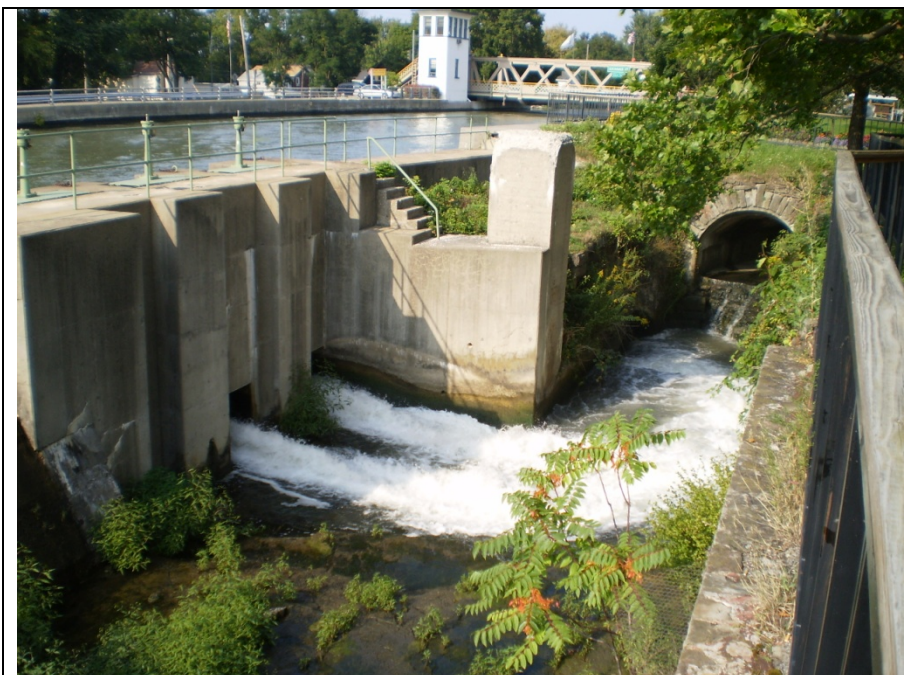
Photo 1

Sluice Gate Structure on Canal within Hall Spillway, combining with discharge from 18-Mile Creek.

Canal locks are operational during the navigation season from early May to mid November (NYS Canal Corporation 2008). During this summer operating season, it has been reported by Canal personnel that two of the three sluice structures are opened 5 inches each. When open, the sluice structures draw canal water off near the bottom of the canal and discharge it into the Hall Spillway on the south side of

the canal. There the canal waters combine with flow from Eighteenmile Creek. The flow from the canal has been previously reported to be approximately 50 cubic feet per second (cfs); however, flow measurements conducted by Ecology and Environment Engineering, P.C. (EEEEPC) in 2008 as part of the Supplemental Remedial Investigation, measured this combined dry weather flow to be approximately 200 cfs. Flow measurements of the East Branch were also measured by the NYSDEC during the Fall of 2009. The average flows for October 29, 2009 and November 12, 2009 were determined to be 91 and 108 cfs, respectively. During dry weather periods, the Barge Canal provides a significant portion of the creek's flow.

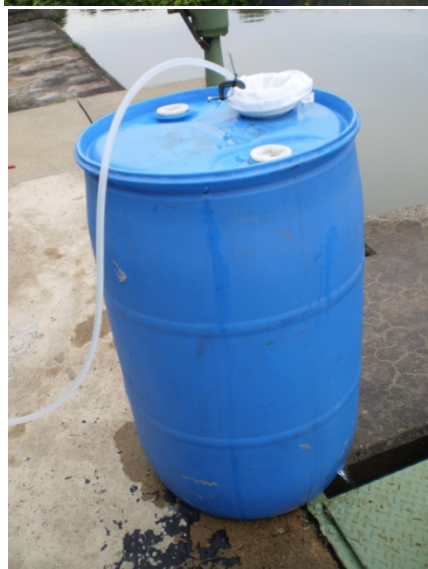
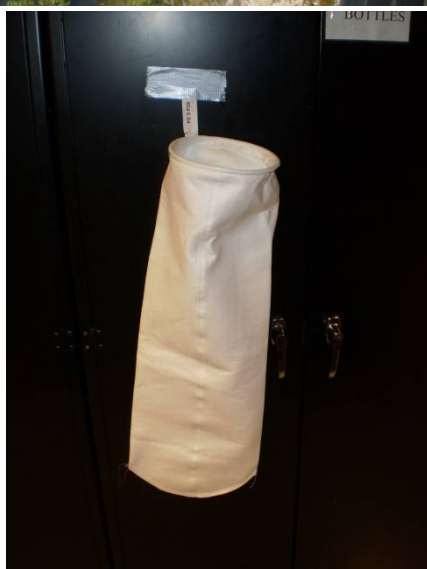
Photos 2 & 3

50 micron Filter Sock & Sampling Drum with Filter Inserted.

Total suspended sediments were collected from the discharge of the Canal into 18-Mile Creek utilizing a Grundfos pump powered by a portable generator. A constant flow of 5 gallons per minute (measured) was pumped through a Pe-5-P2S - 5 micron 7"x32" polyester felt filter bag, as shown in Photos 2 and 3. Filtered water was allowed to re-enter the Canal at the surface and downstream of the sample point.

It was hoped that sufficient quantity of sediment (4 oz.) could be collected using this sampling method to submit to an analytical laboratory for sediment analysis. The system was operated for a period of approximately 5 hours for a total flow of approximately 1500 gallons passing through the filter media. While the filter was severely stained dark brown with collected suspended sediment after this period, no free, collectable sediment was observed in the filter bag. As an alternative sampling method, the bag media was cut into six, four inch square pieces, and submitted to the laboratory for PCB analysis. These samples were extracted, analyzed and reported similar to a "wipe" type sample providing a qualitative indication of the presence of PCBs within the suspended sediment collected on the filter material.

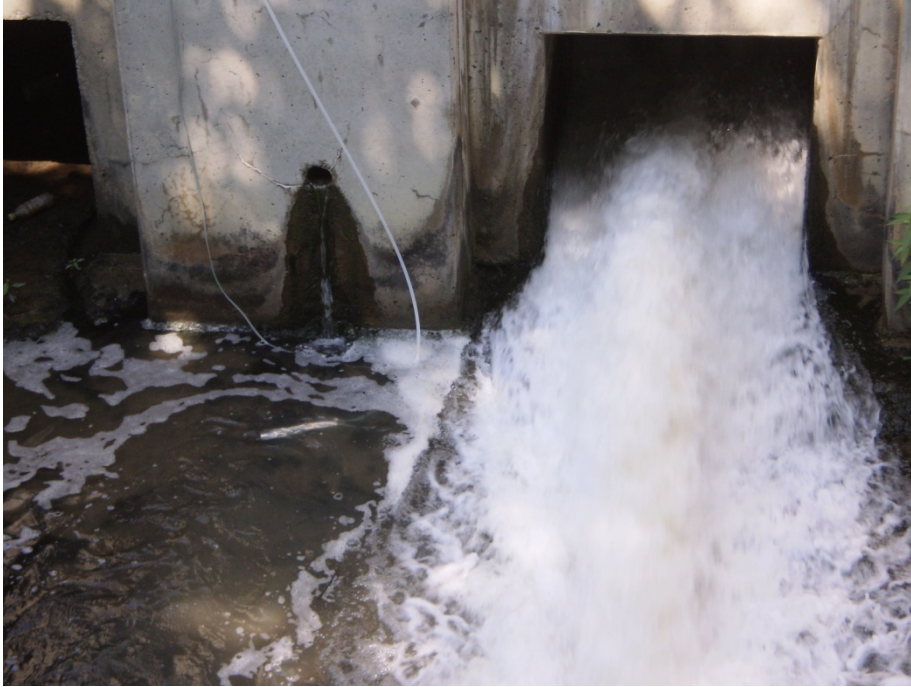
Photo 4

Canal Sample Location
at base of sluiceway
discharge (N39801).

The four unfiltered surface water samples from Eighteenmile Creek were also collected and submitted for only PCB analysis by EPA Method 8082. The water samples were collected from just below the water surface. These samples were located at points in the stream that have been identified as being downstream of areas previously shown to have elevated levels of PCBs in stream sediment; ie: Olcott Street Bridge, North end of Flintkote Millway, Transit Road Bridge, and Stone Road bridge. The purpose was to determine if re-suspension of contamination is occurring through these areas, conveying PCB contamination downstream from the Eighteenmile Creek Corridor Site. Sample locations are shown in photos 4 through 8, and on Figures 3 and 4.

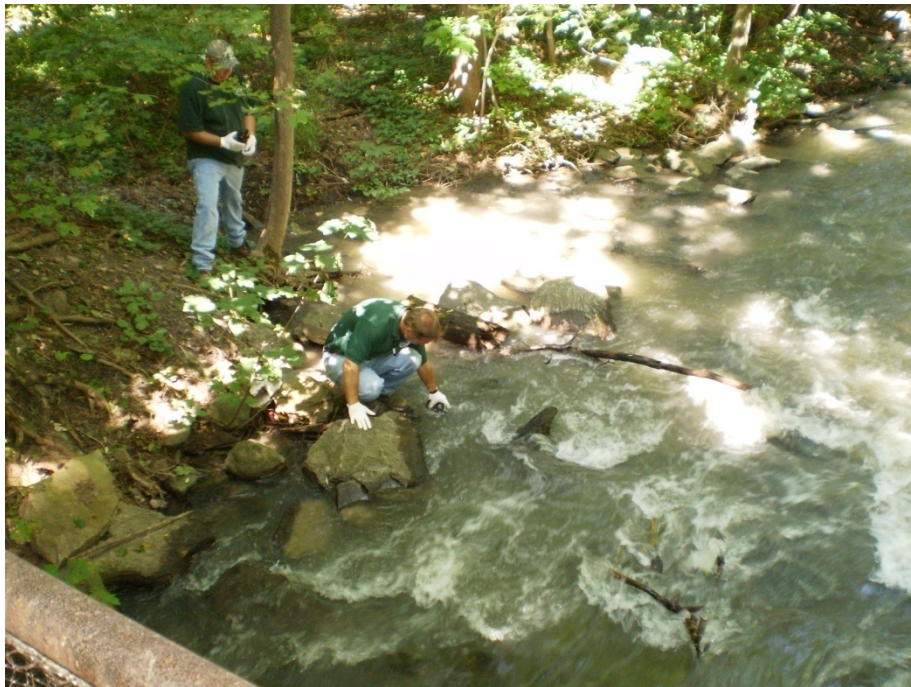
Photo 5

18-Mile Creek Sample
Location (N39802)
downstream of Olcott
Street Bridge.

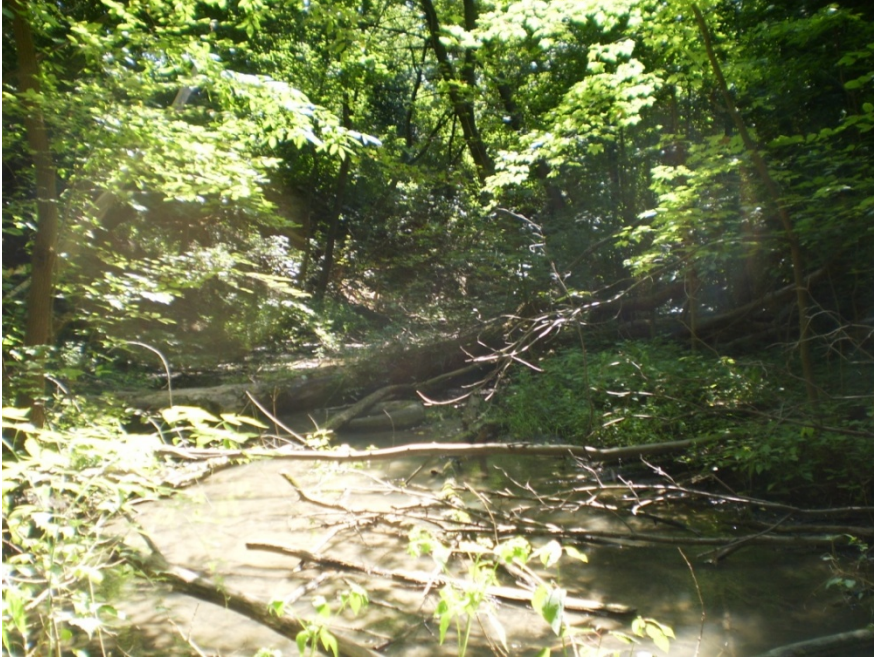
Photo 6

18-Mile Creek Sample Location (N39803) at terminus of Mill way side channel into main creek.

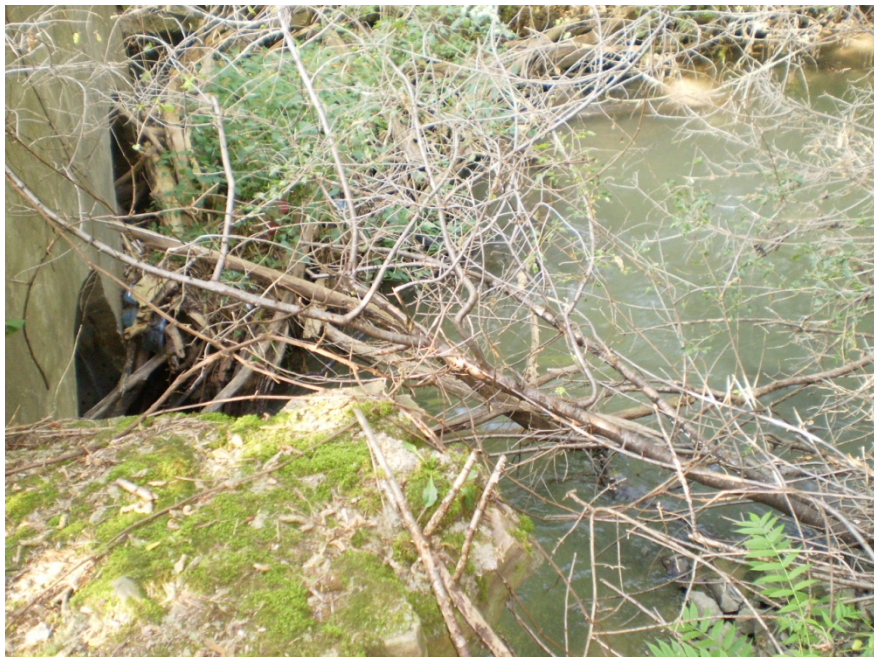
Photo 7

18-Mile Creek Sample Location (N39804) upstream of Transit Street bridge.

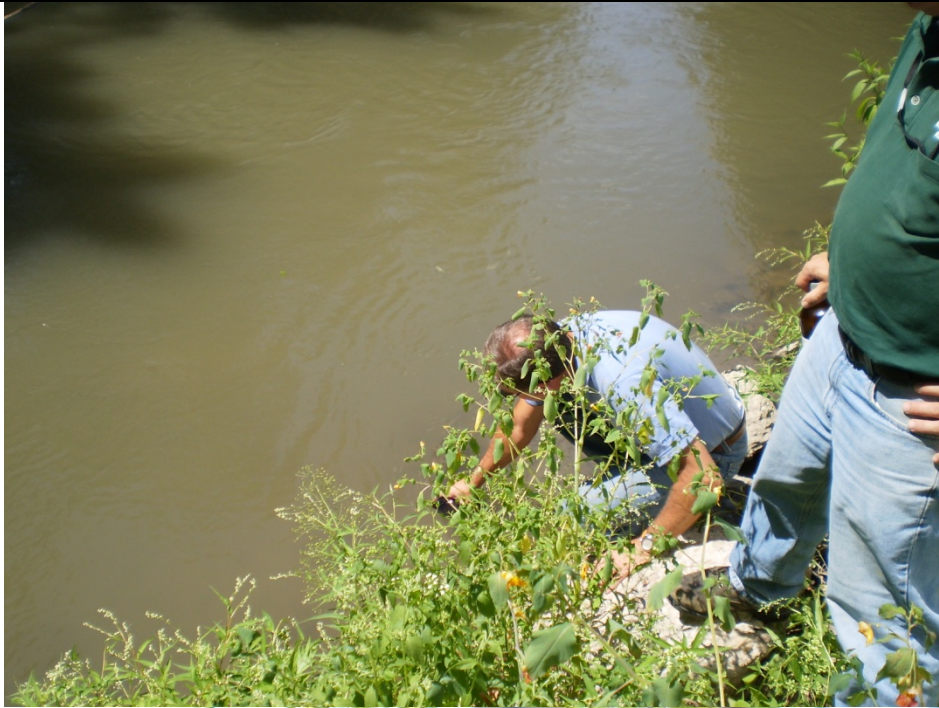
Photo 8

18-Mile Creek
Sample Location
(N39805) upstream
of Stone Road
bridge.

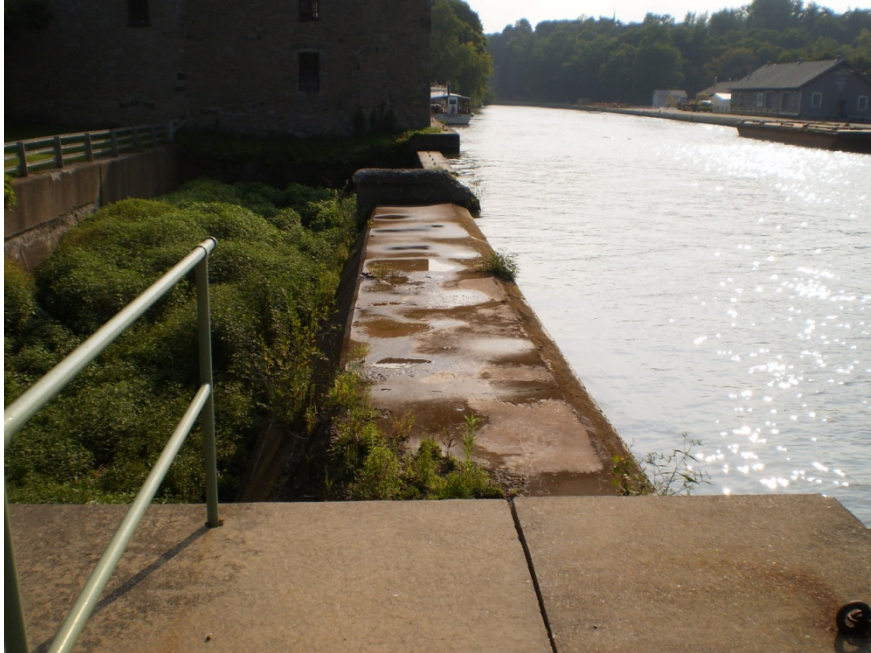
Photo 10

Canal Weir overflow structure before lock opening events.

locations were sampled during normal Barge Canal operations and dry weather flow conditions. As shown in the Photos 10 through 13, the canal locks were in normal operation and overflows to the system were occurring on a regular basis due to the operation of the lock system up stream. This would indicate a worse case condition when Canal sediments have the greatest chance of disturbance from surcharges created when locks are filled and emptied during the passage of boats. The water samples were collected from just below the water surface. The unfiltered sample from the canal was submitted for total suspended solids (TSS) analysis by EPA Method SM2540D (see Tables 1) and PCB analysis by EPA Method 8082 (see Table 2).

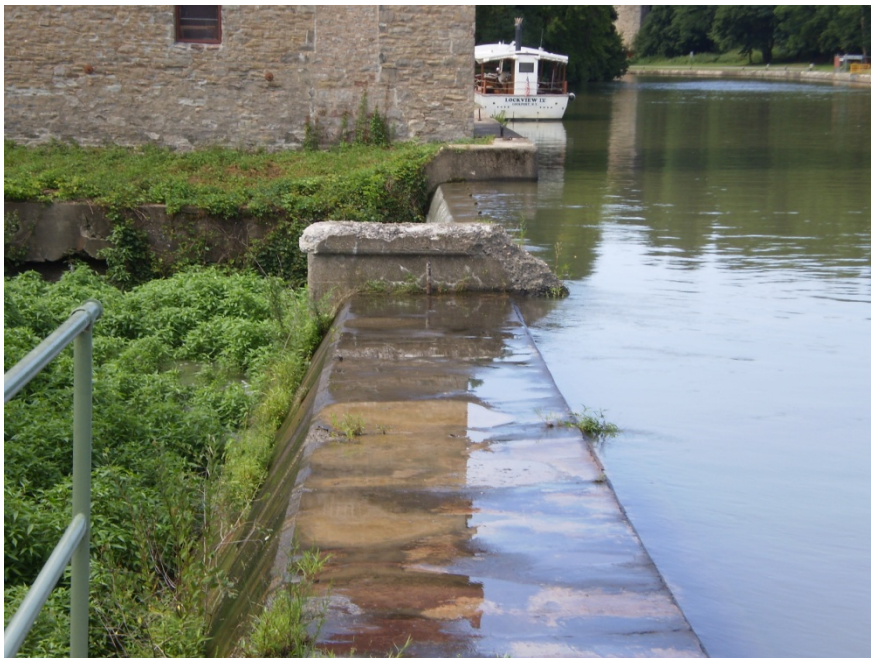
Photo 11

Canal Weir overflow structure during lock opening events.

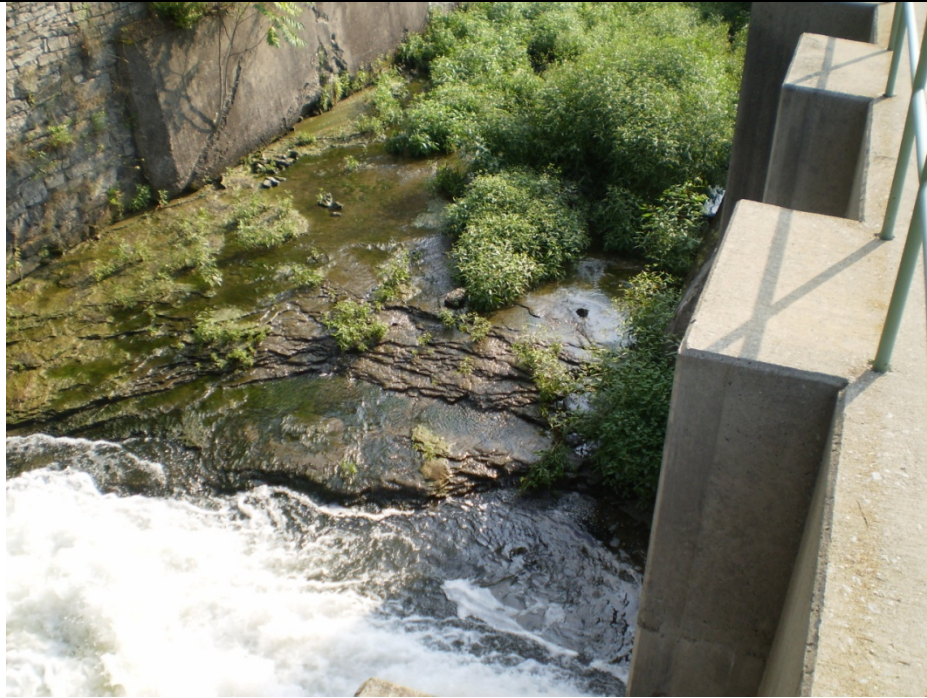
Photo 12

Discharge to Creek from Canal Weir overflow structure before lock operating event.

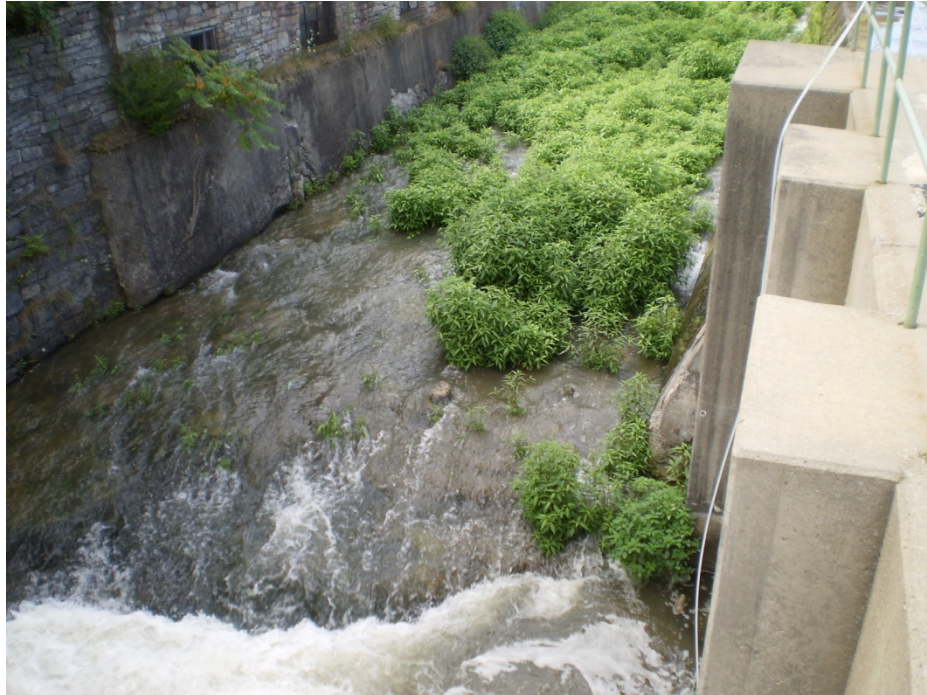
Photo 13

Discharge to Creek from Canal Weir overflow structure during lock operating event.

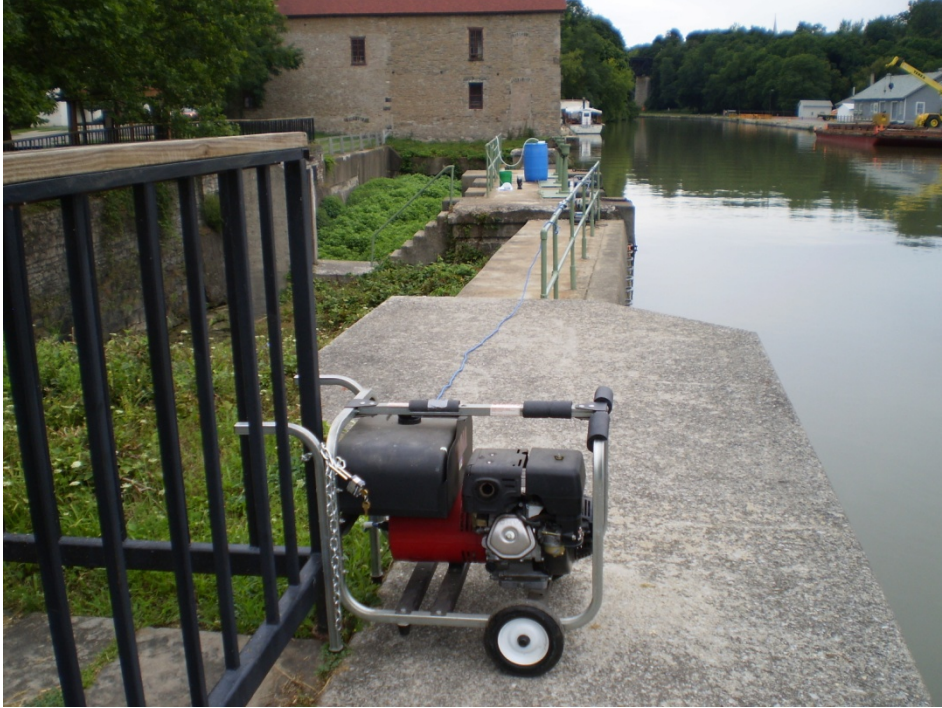
Photo 14

Sampler Set-up on edge of canal.
