**Trackdown of Chemical Contaminants to Lake Ontario from
New York State Tributaries**

Simon Litten

April 11, 1996

**Bureau of Watershed Assessment and Research
Division of Water
New York State Department of Environmental Conservation**

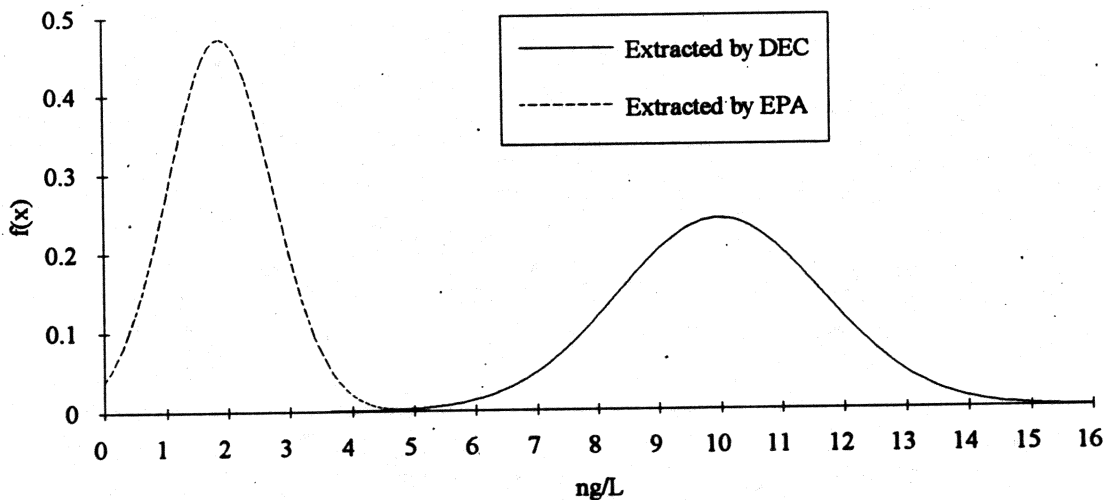
Figure 2. Comparison of GLSE PCB extractions done by EPA and NYSDEC. All chemical analyses were performed by the NYS Department of Health. Means and variances from the two field teams are expressed as normal probability distribution curves.

All samples were taken through a single submersible pump. Subsamples from two ports at the top of the intake were directed toward two Pentaplates by peristaltic pumps. The two subsample tubes entered identical Pentaplate pressure filtration units each of which was loaded with three pre-fired 293 mm glass fiber filters which were supplied by the *R/V Lake Guardian*. After filtration the clarified water entered five 20 L glass carboys (90 L). Five carboys from the *Guardian's* Pentaplate were driven to the ship, some seven miles distant, for GLSE processing and the five carboys from the DEC Pentaplate were extracted in the mobile lab. The results are summarized in Figure 2. The figure shows the larger scatter in results from NYSDEC and the great difference between extractions done in the two settings.

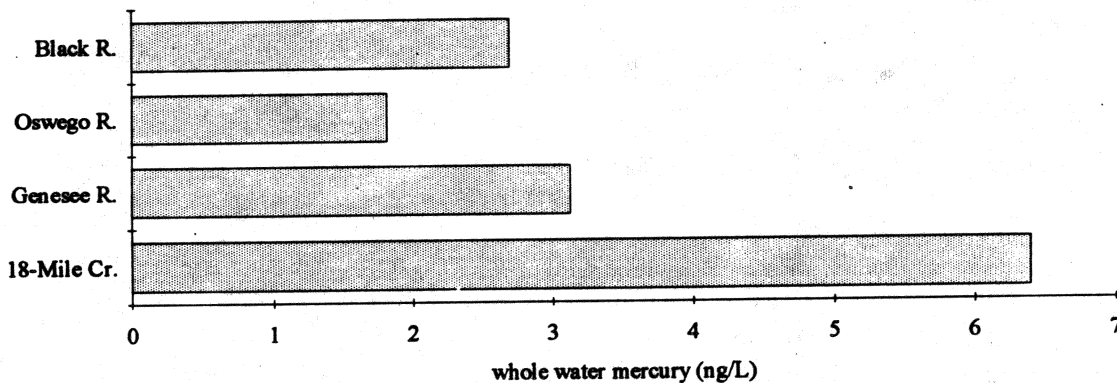
Figure 11. Median concentrations of mercury at the four principal sampling sites.

Of the four primary sites, mercury concentrations were greatest at Eighteenmile Creek.

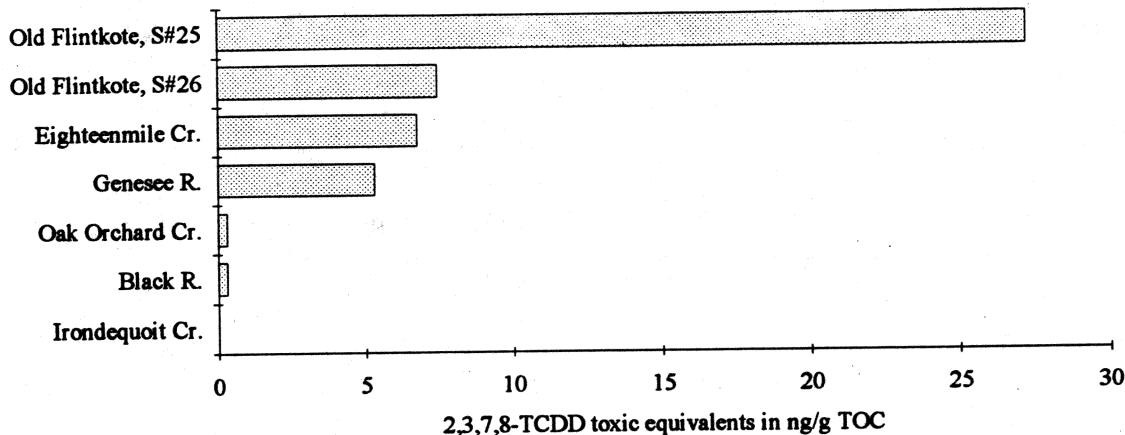
2,3,7,8-TCDD was measured. Comparisons between dioxin/furans from sediments and filters are difficult. The total amount of solids collected on the filters was small and the concentrations of TCDD TEQ/mg TOC appear to be smaller than those from sediments. It is possible that this is an artifact of sampling.

Figure 13. Dioxin and furan concentrations in sediments and soils expressed in TEQs and normalized by TOC.
